Building a Log Cabin

Contained on this and following pages is a pictorial display of a 2-story log cabin house and adjacent 2-story garage recently built in the woods of North Florida, USA. The home was built by two people - Clyde and Rosemary - without the help of contractors or hired help. Clyde has worked full-time during most of the construction period, so only a few days of the week are available to work on the house. The home is built from logs bought at BK Cypress, Bronson, FL. This photo shows what the house looked like from the front in February, 1998.

Construction Photo Album

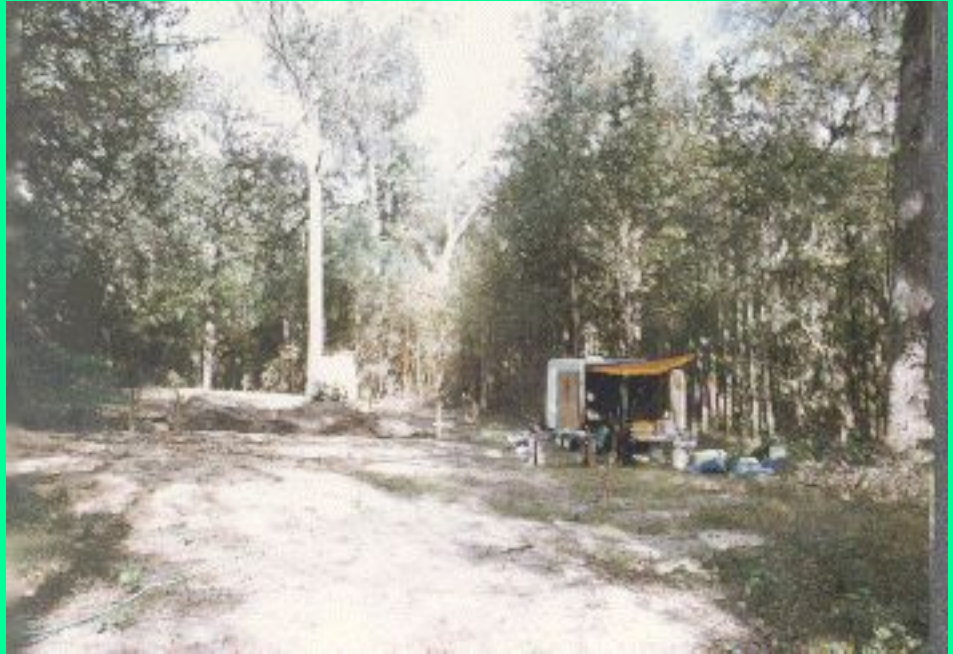
Before anything was built. Slightly to the left of center is the location that will house the garage. To the right, slightly out of camera view is the location of the house (not yet started in this picture). The tree that hugs the right side of the picture is located just off the back edge of the house. The house is being built from logs bought from BK Cypress, Bronson, FL. **Be sure to visit the main page for more pictures and information.**

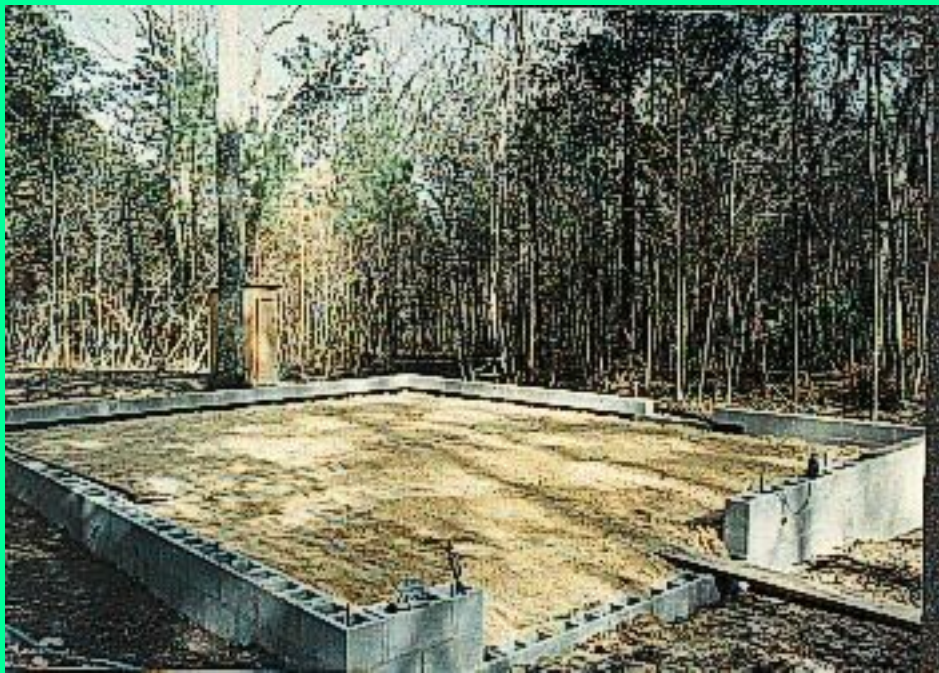
The slab. The outline of where the slab for the garage floor. The garage is a simple frame building and not nearly as complex as the house will be. Leaning against the tree in the background is a much needed item on a construction site - the outhouse. The area behind and to the left of the tree is where the septic tank and drain field are located. The garage (which has a 2nd floor apartment) provided a temporary living place during the construction of the house.

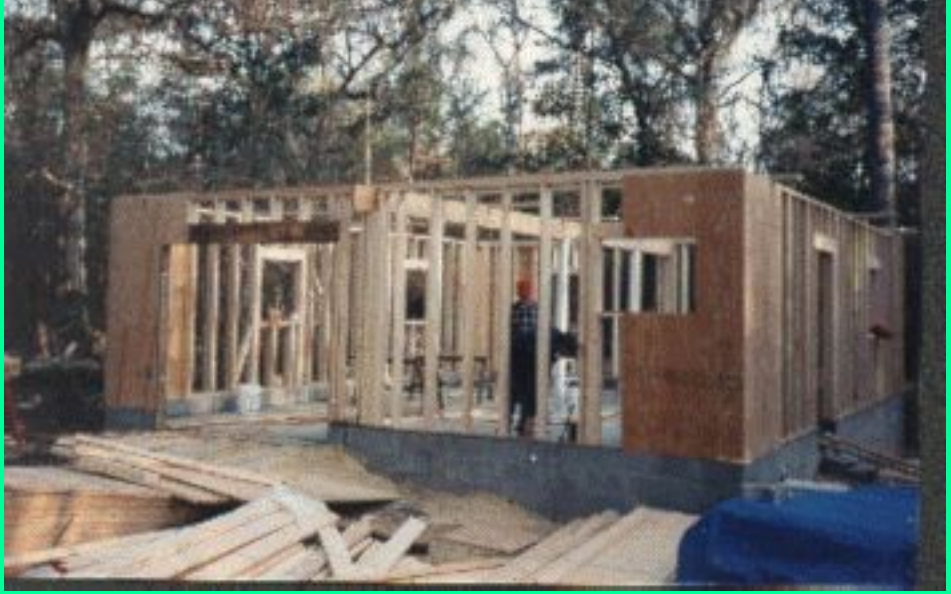
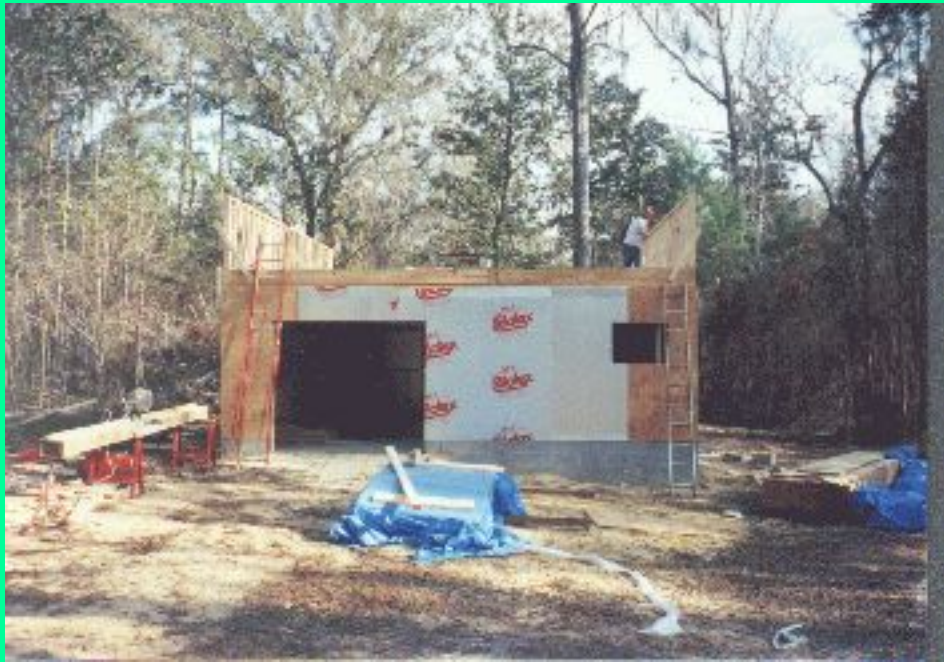
2nd floor is put up. As with the house, the 2nd floor roof slopes such that the walls only go up about 3 feet along the walls. The garage loft has a normal height ceiling where the house will have an open beam ceiling.

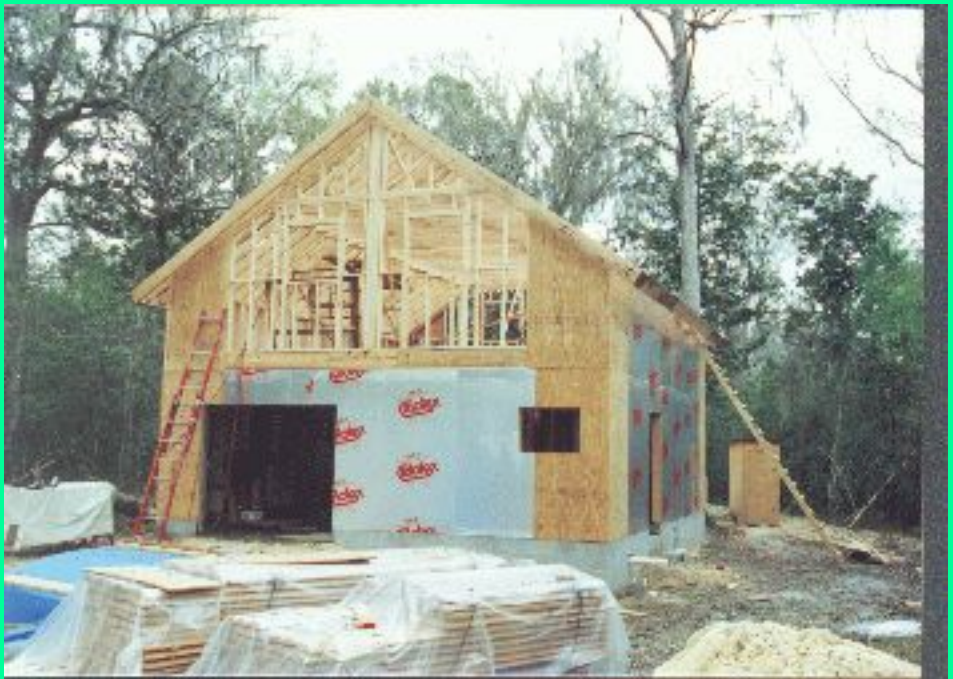
2nd floor and roof beams. The garage will have a tin roof.

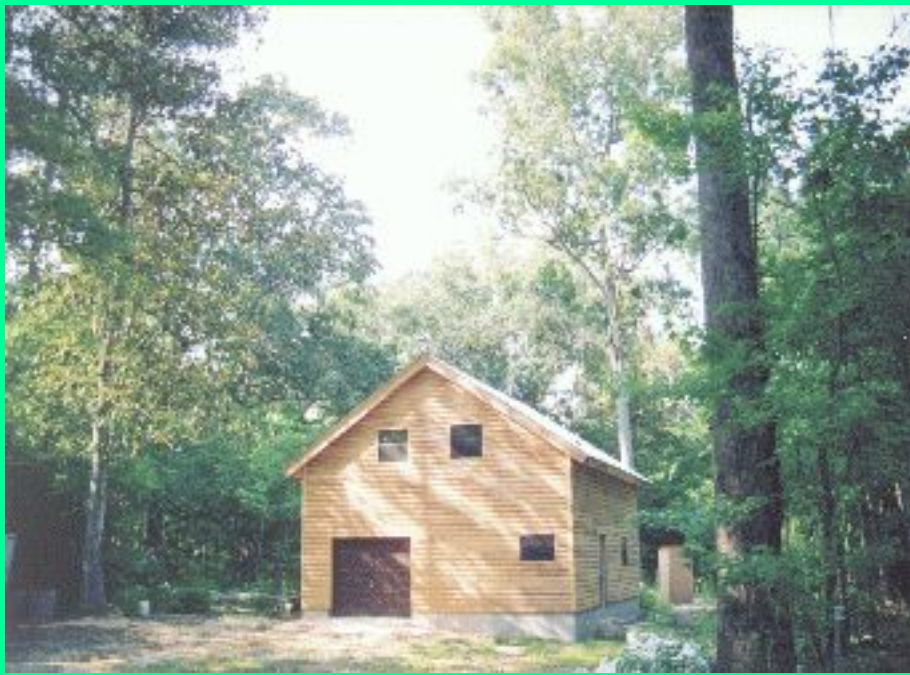
Finished outside of garage. The outside of the garage has a log facade to match the look of the real logs of which the house are made. The interior of the garage, which includes a bathroom and a small kitchen are not included in these pictures. Many of the house pictures were taken from the left-most 2nd story window of the garage shown in this picture.

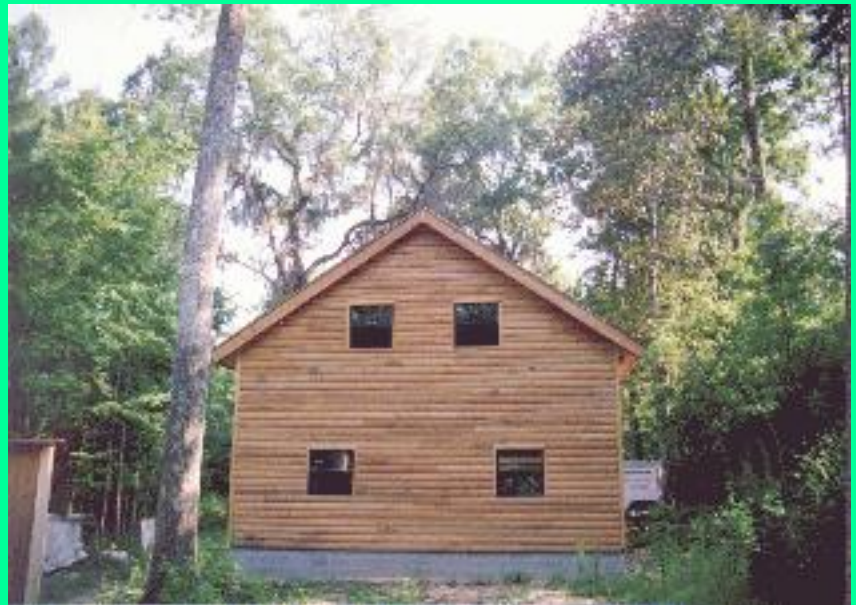
Back of the garage. A view of the back of the garage. In this view the house would be barely visible between the tree and the left edge of the garage.

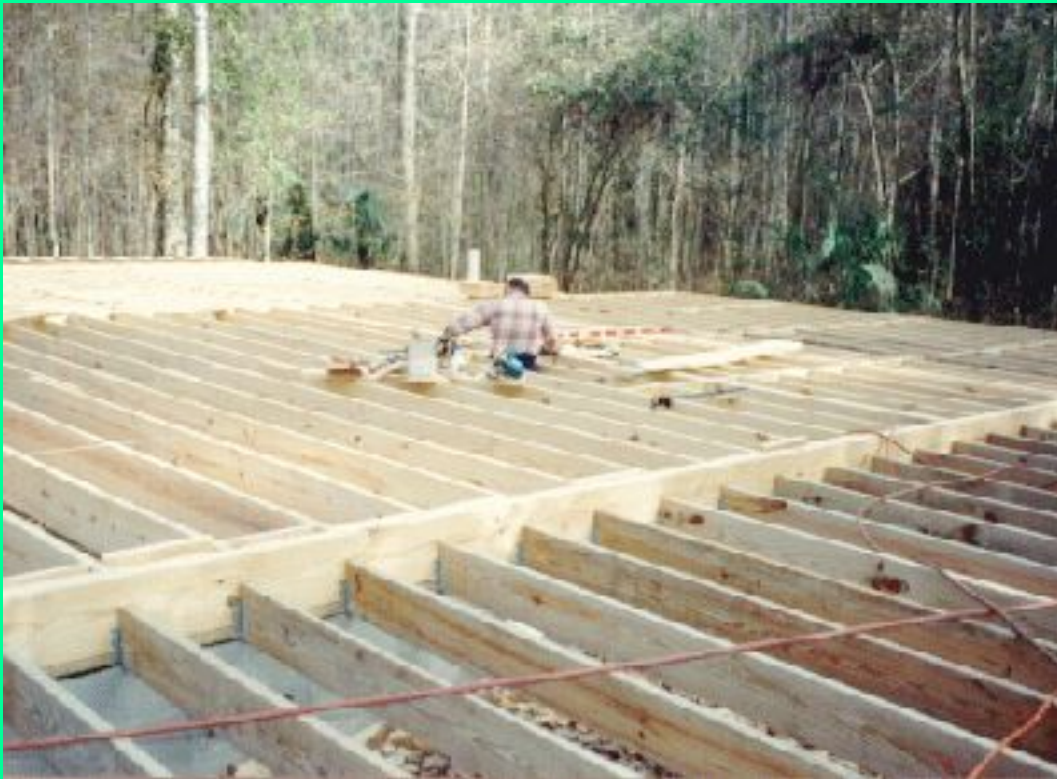
Floor support

These beams will support the first floor and the larger beams will support the internal walls and much of the weight of the building. This view is looking from about where the living room will be toward the northeast corner.

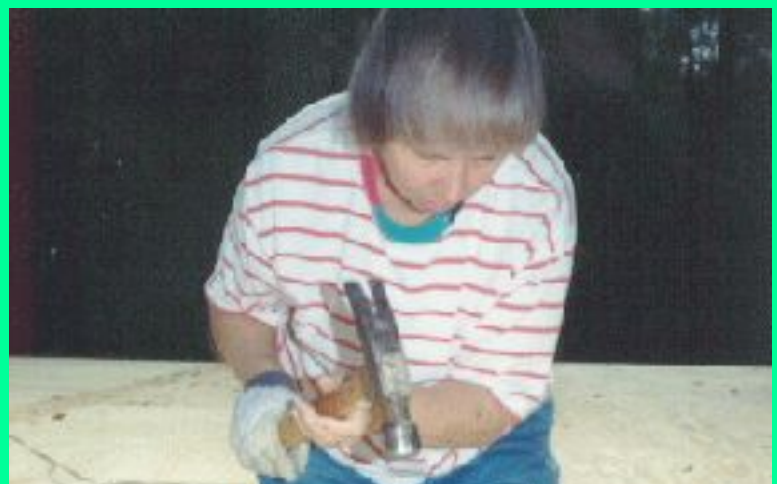
Nailing the sub-floor

Here is Rosemary nailing in the plywood that will become the sub-floor for the first floor.

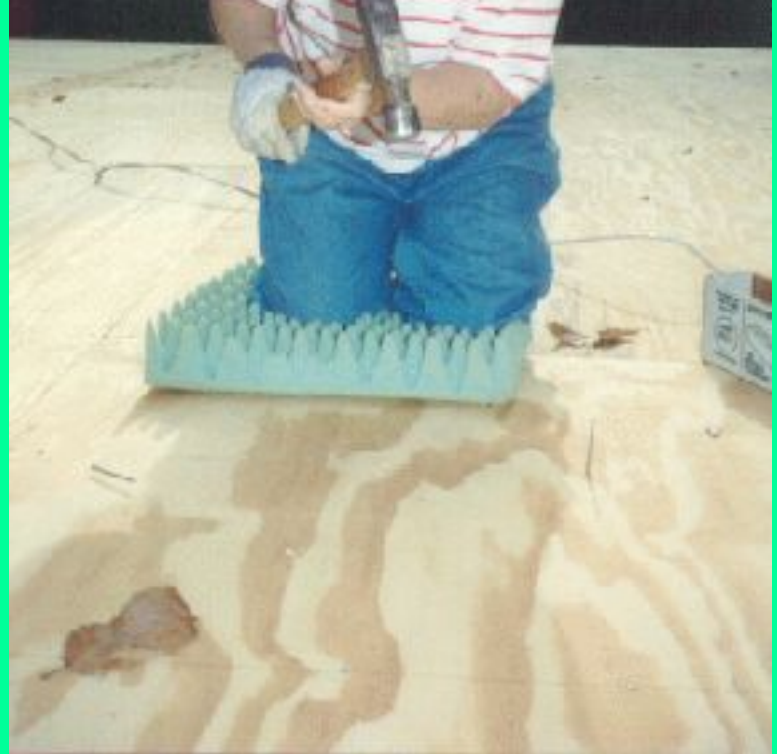
Sub-floor

Some of the support blocks can be seen in this picture. The portion of the house that is not complete is part of the back/side porch which raps around from the west center and goes full across the northern/back side of the house.

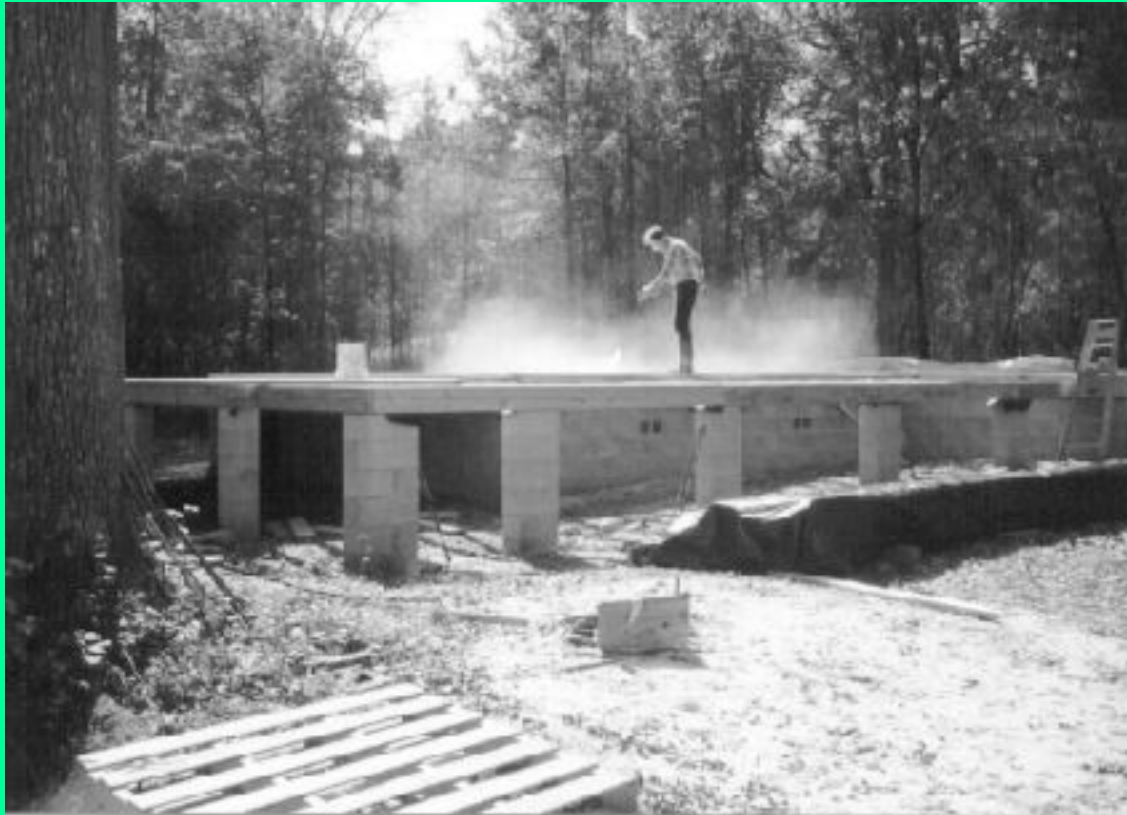
Sealer

Here is a view of a water sealer being sprayed over the entire sub-flooring. Since the log walls and roof took *six months or more* it was absolutely necessary to put some sort of sealer on the sub-flooring in order to protect it from the elements. A better view of the back/side porch and the support blocks can be seen. The white blur to the left of the picture, under the porch is the exiting sewer line.

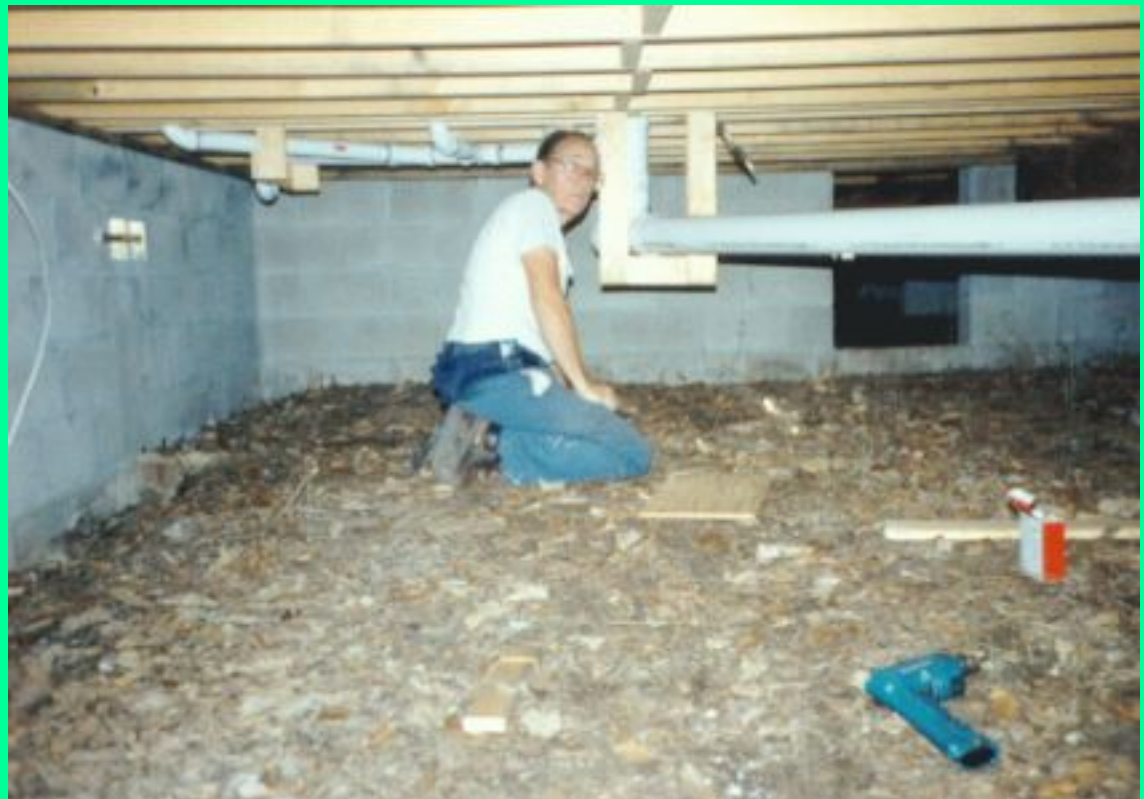
Sewer line

Here is the view under the house with Clyde shown checking out the sewer line connection. For over three years the exiting sewer line ended at the back porch until the pipe was layed back to join the garage's line near the septic tank. (See previous pictures).

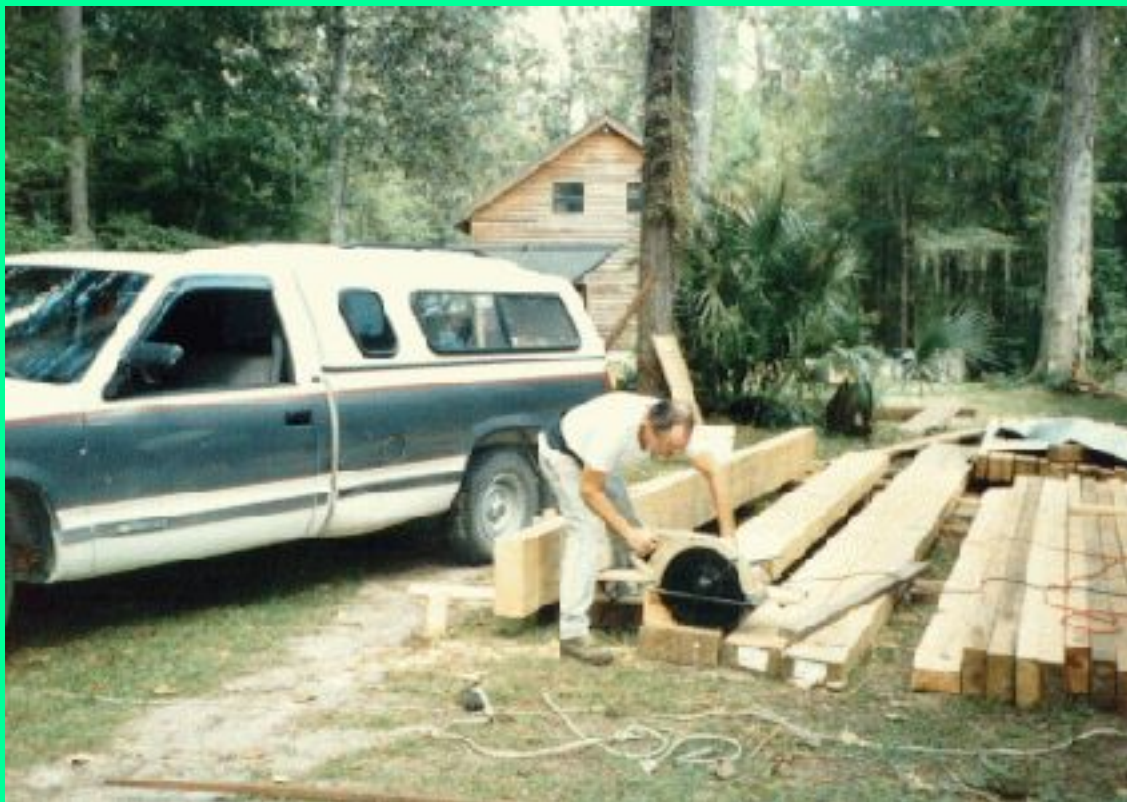
Big enough saw?

Here is a picture of the logs being cut with a saw that had to be specially purchased for the job. This is NOT a kit home. Simply put, Clyde and Rosemary went to the sawmill (BK Cypress Logs, Bronson, FL) and gave them the house plans and a bunch of logs were delivered (as seen in other pictures). All the logs have to be cut to compensate for corner pieces and special situations, such as windows and door.

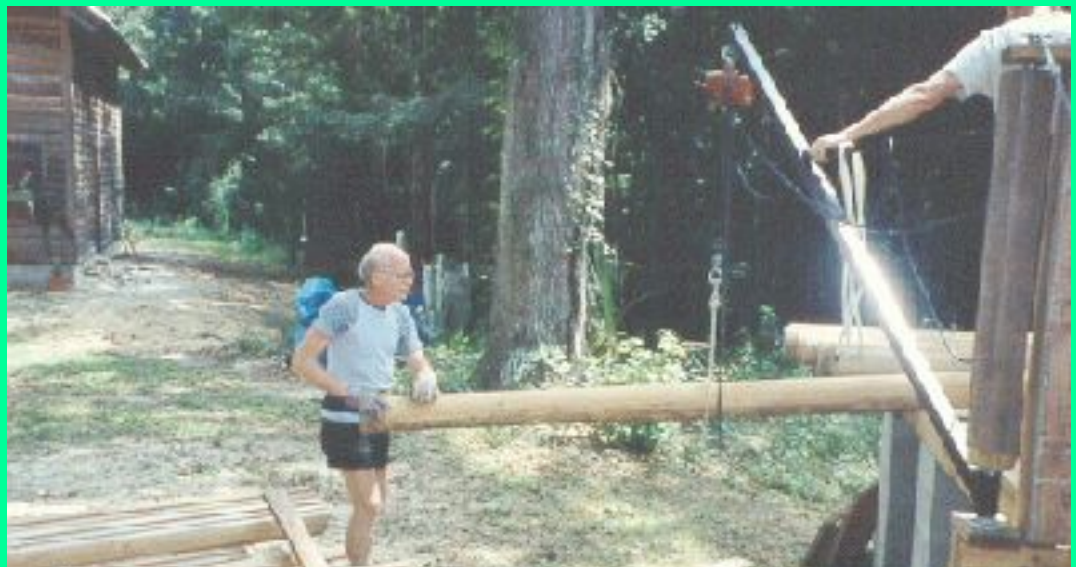
Lifting the logs

As you can imagine, these 8, 10 or 12 foot cypress logs weigh a lot, even when cut to smaller sizes. Here a relative who came to visit and got drafted into building guides a log onto the porch. The device being used to lift the logs was designed by

Clyde and consists of an engine chain/motorized hoist attached to the swinging arm.

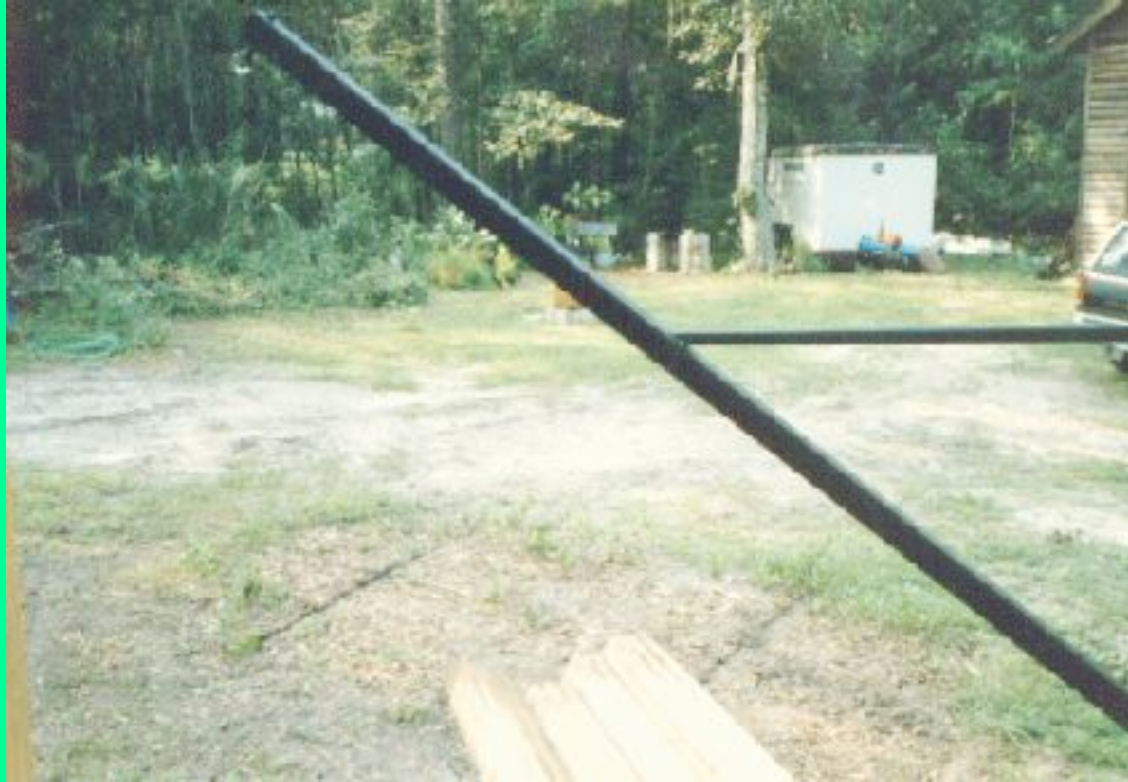
The lifter

A closer look at the lifter. This was used to get the logs up to the 1st floor level, which is raised above the ground level. Another contraption was invented to handle raising the logs above the 3 or four foot mark.

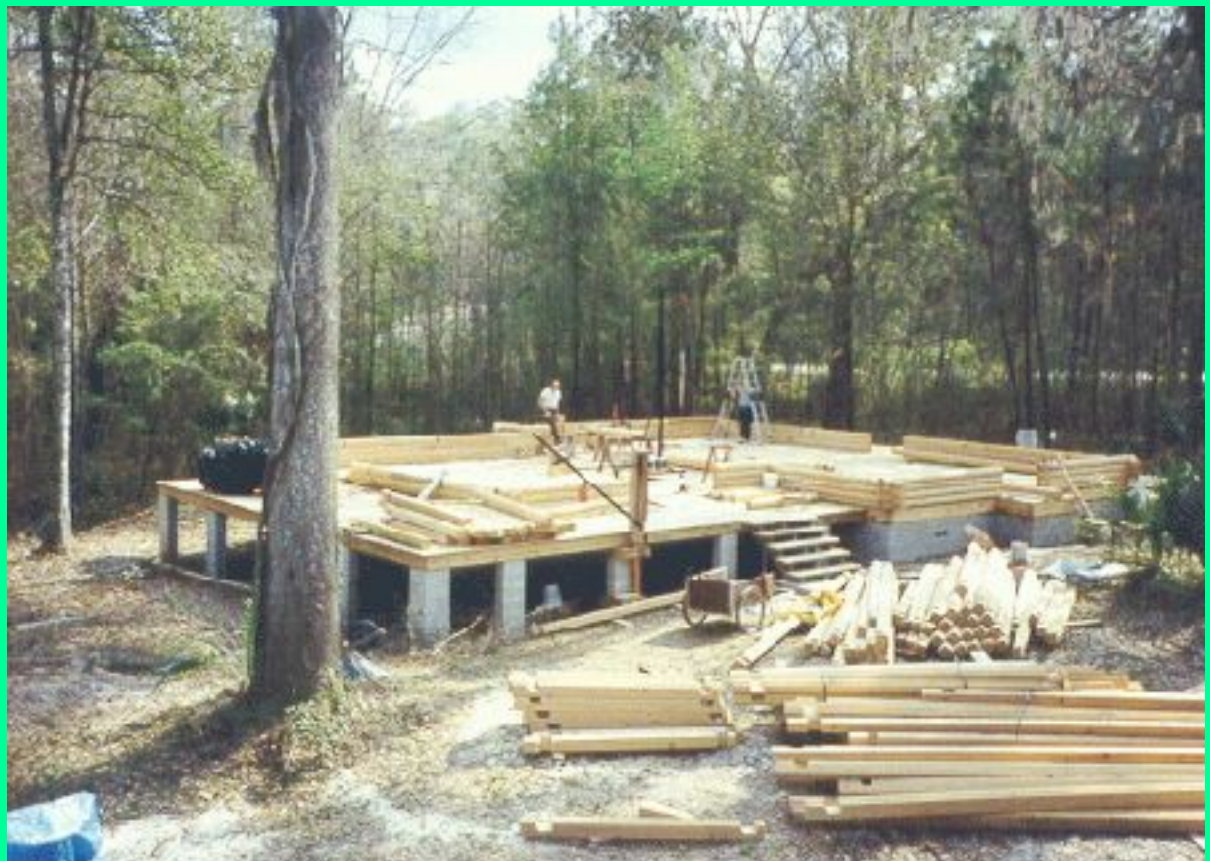
Logs are laid

This shows the first bunch of logs being layed. Note the pile of logs in the foreground.

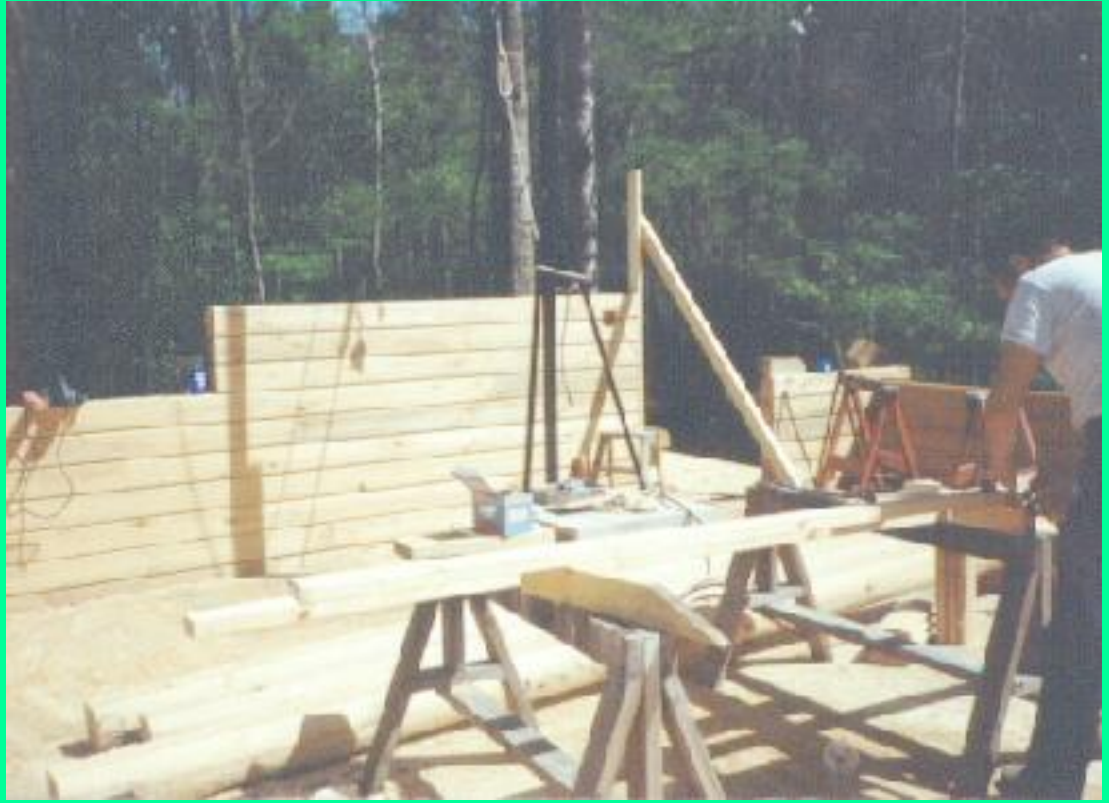
Windows frames

This shows all the first floor logs
up to the top of all the windows.
Note also door frames and
window frame supports are in
place as is the basic frame for
the fireplace.

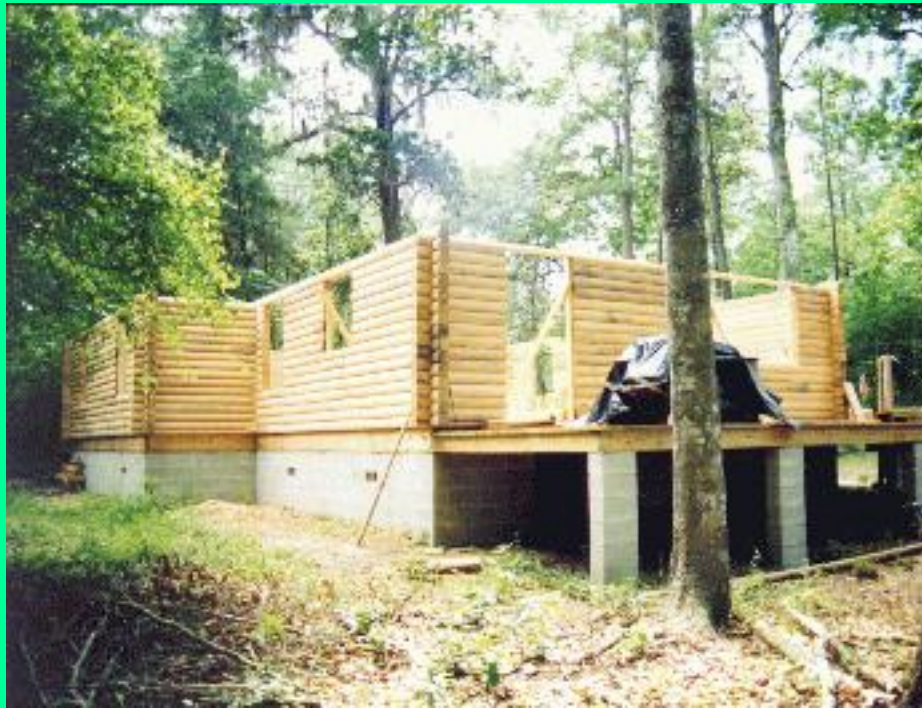
Back view

This shows the back, northeast corner of the house at the point where there is one log above all of the window and door frames. The door in the foreground is the door to the pantry.

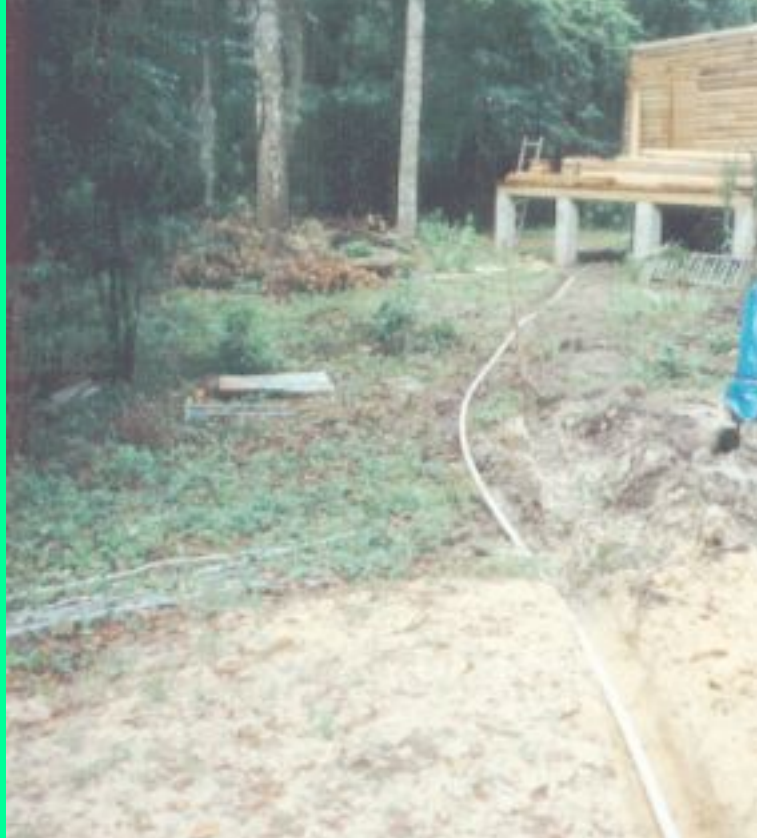
Water Line

This shows the water line running from the garage - where the water filter is located - to the main house.

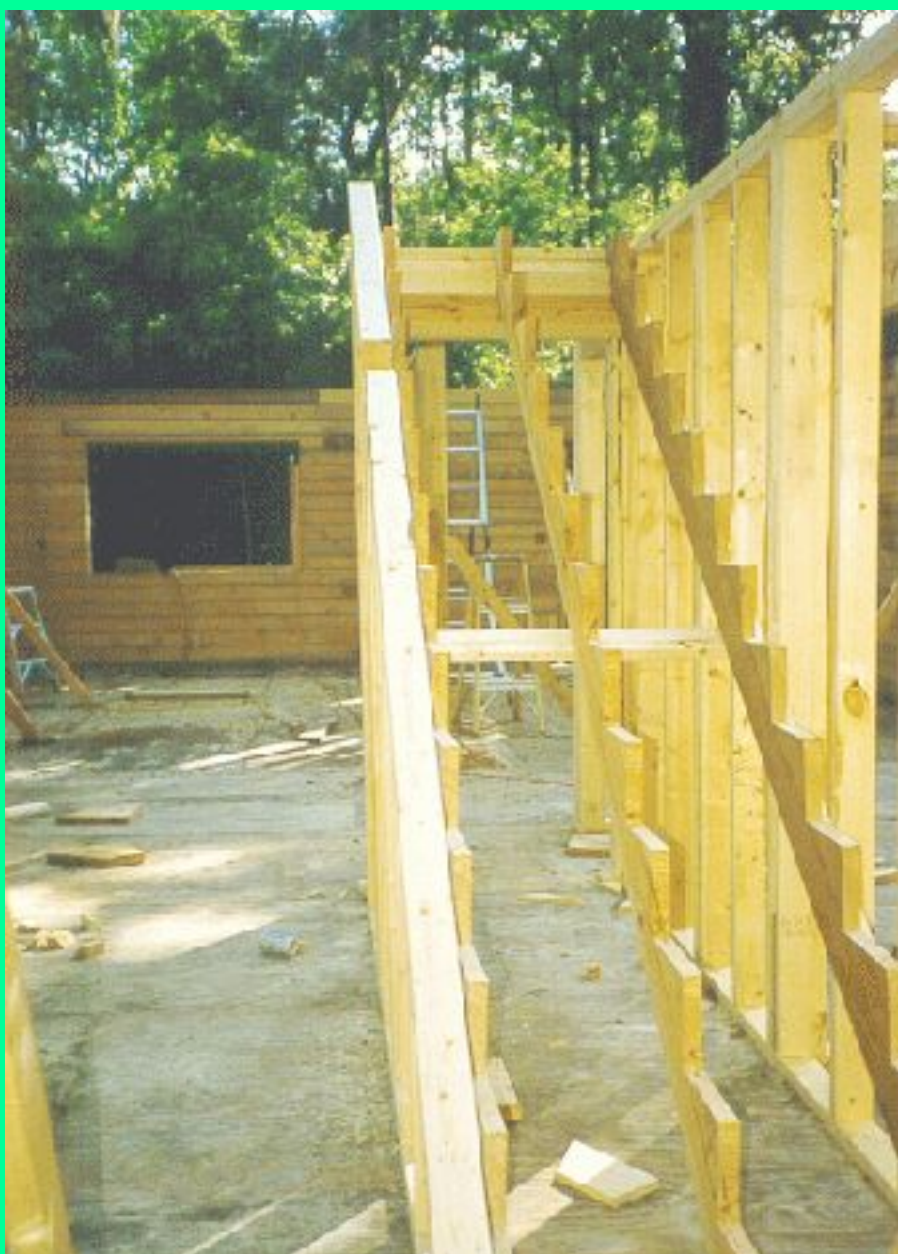
Front door, looking in

The frame for the stairs as seen from what would be the front door. You can also see some of the inside first floor walls.

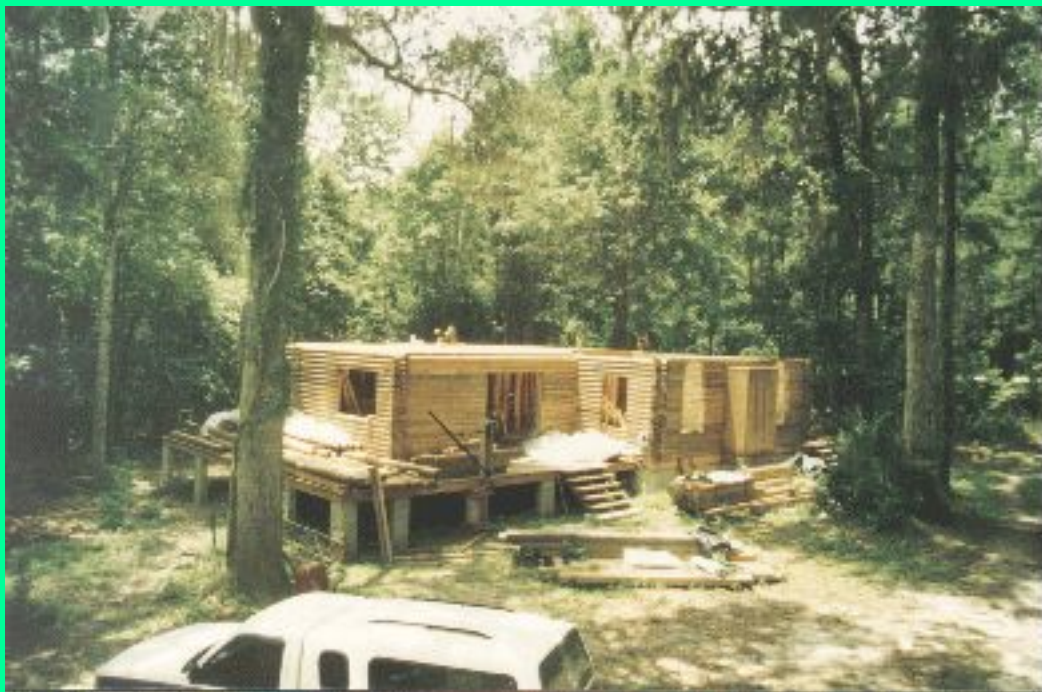
2nd Floor

The 2nd floor is put in. This is the final floor, not a sub floor or temporary floor. As the roof was not put on for several months after this, the 2nd floor required sanding to get rid of mildew and crud. Over 1,000 screws were used to screw the floor in place.

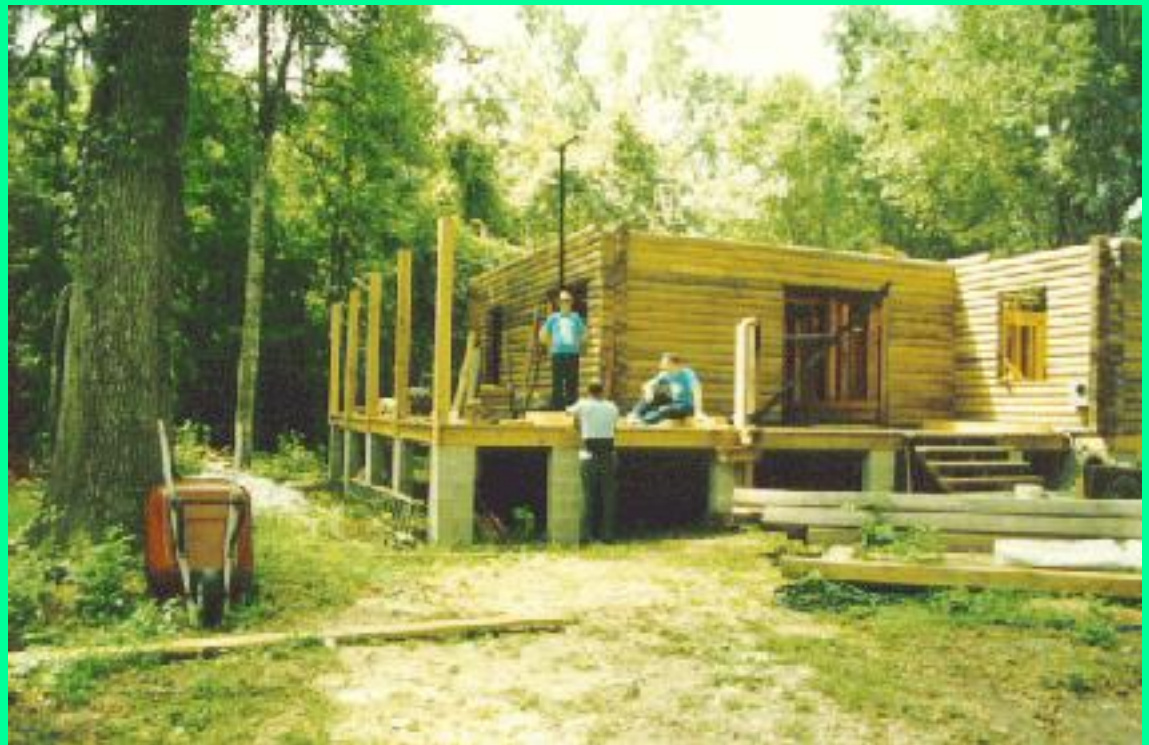
2nd Floor and porch

The 2nd floor can be seen here as the beams to the back porch go in. The porch roof beams will join in at this level and have to be done before any of the 2nd floor logs can be put up around

the porch area.

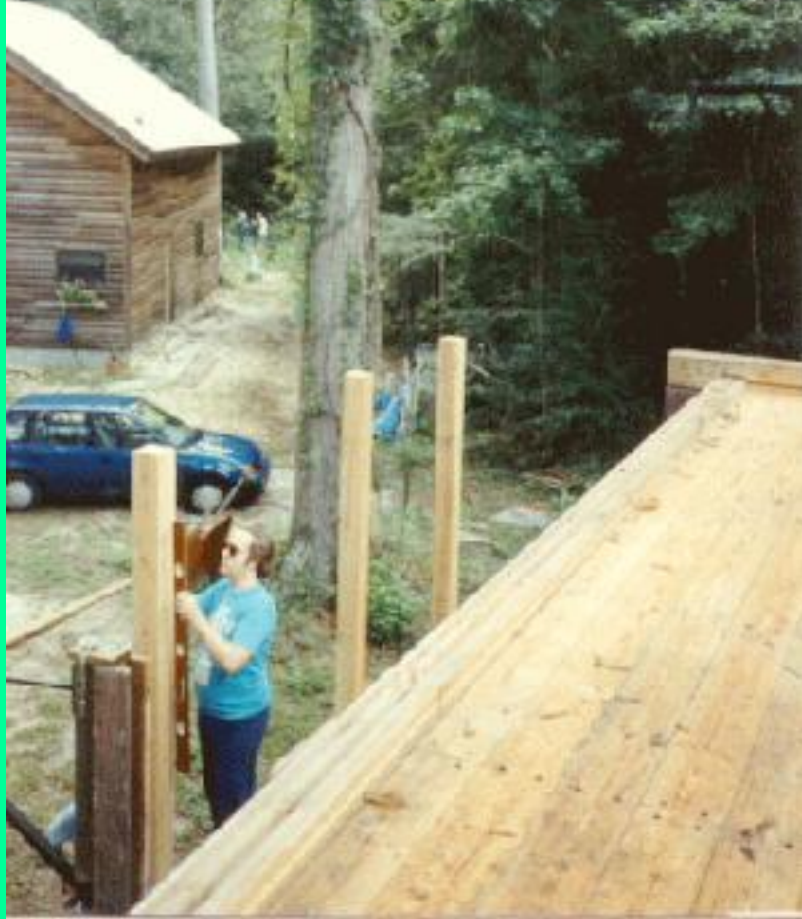
Chimney frame

Here is the chimney frame. On the outside of this will go tar paper and Florida field and stone masonry work. Note Clyde inside the chimney.

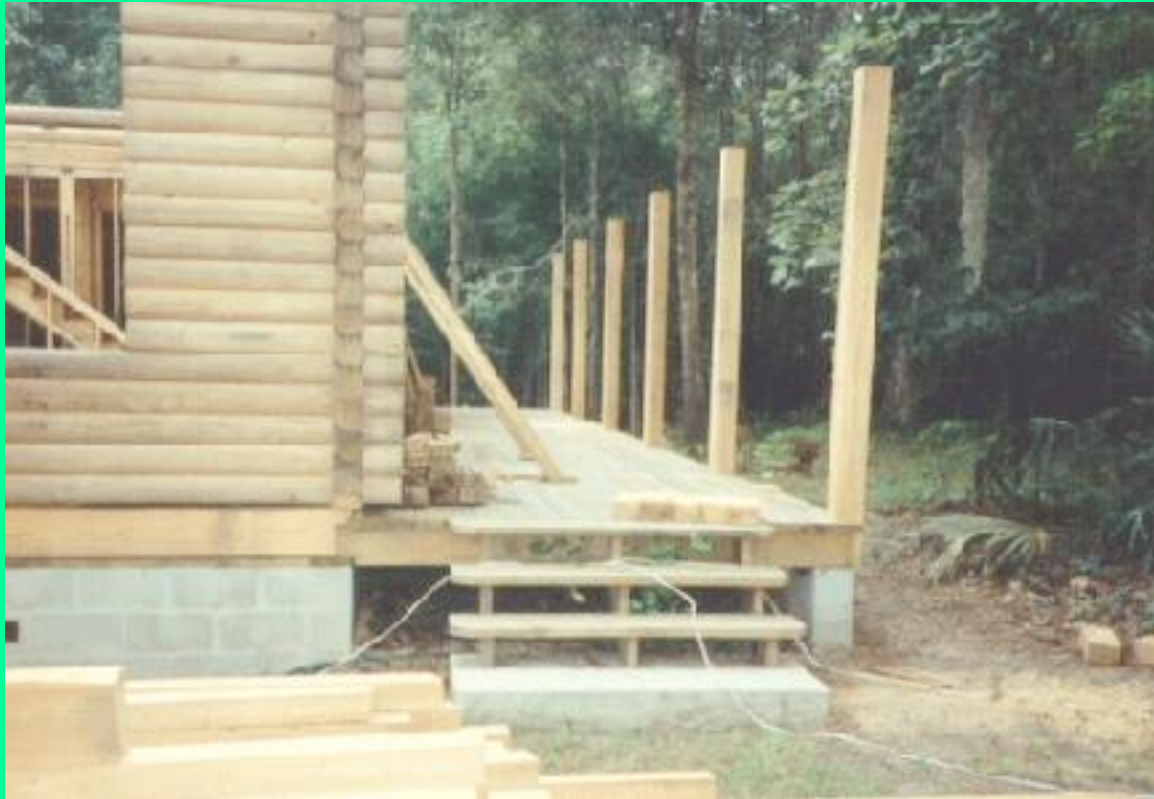
Front porch

Here the beams to hold the front porch are put in place.

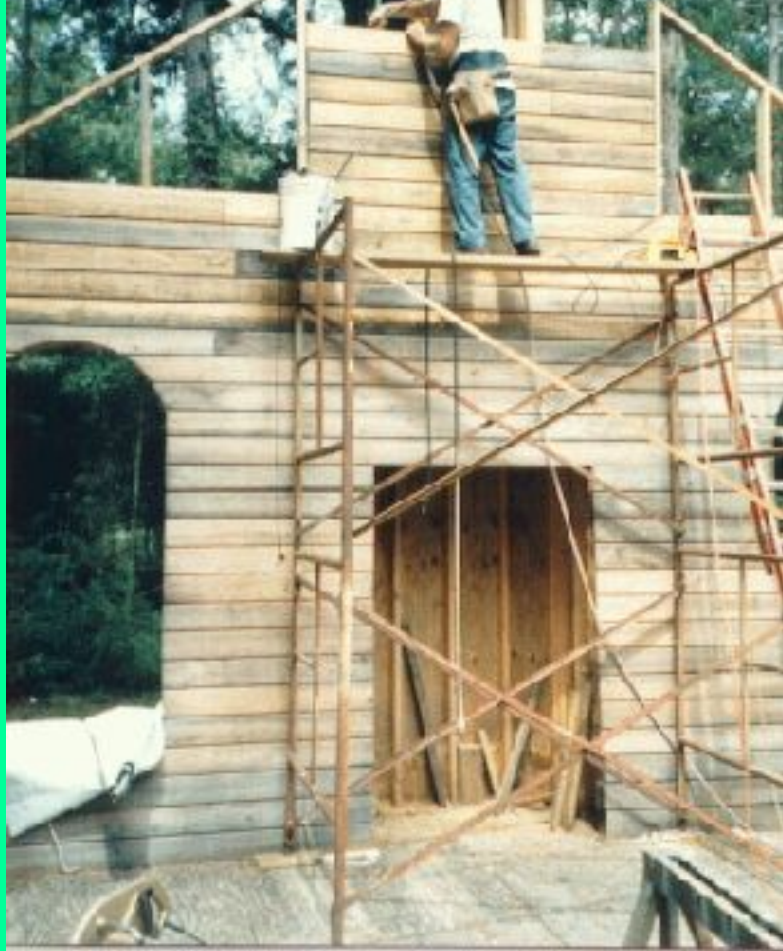
Lifting logs

One of the sons of the owners helps lift logs from the living room up to the 2nd floor. Note the contraption being used to lift the logs. It was invented by Clyde to help lift the logs. Once again, the engine hoist/

chain is
being used.

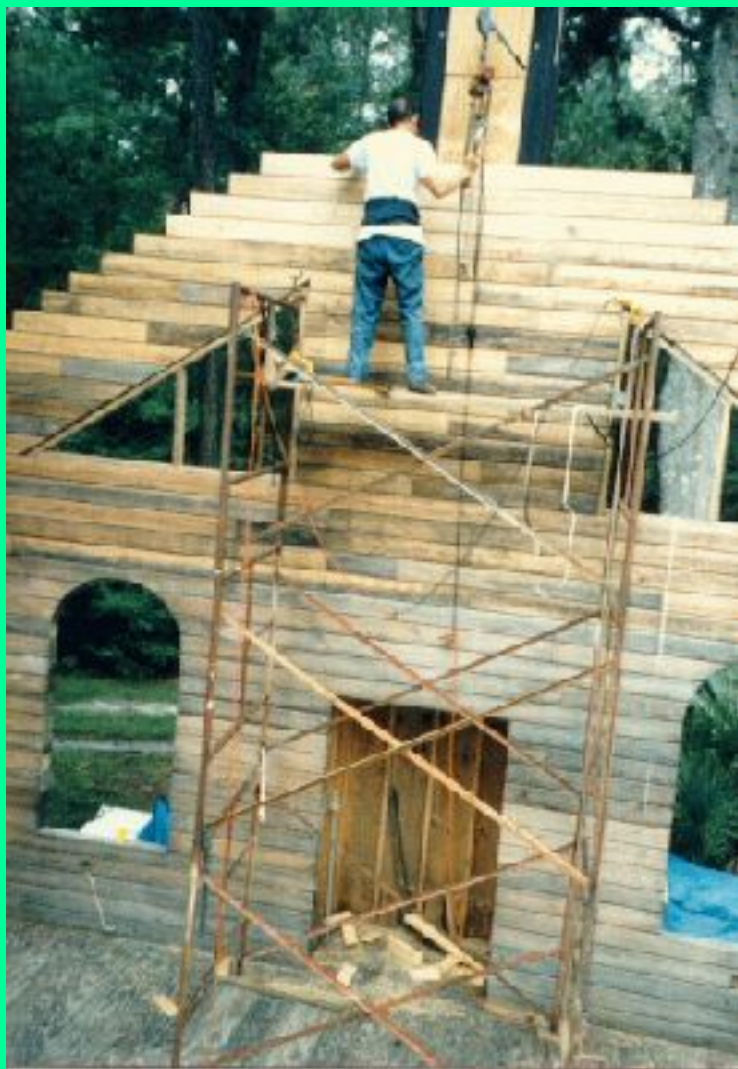
Cathedral Ceiling

More 2nd floor level logs get placed in the living room. Notice that the triangle windows are already installed. They are fixed windows that will not open. Picture is taken from the 2nd floor balcony. The triangle windows and the curved windows below required the use of a chainsaw to cut through the logs. Another contraption is being used to lift the logs. The big opening at the bottom is the fireplace opening and is a little over 6' high. The opening itself will not end up being that big and will be covered in by the fireplace workings and log facades as needed.

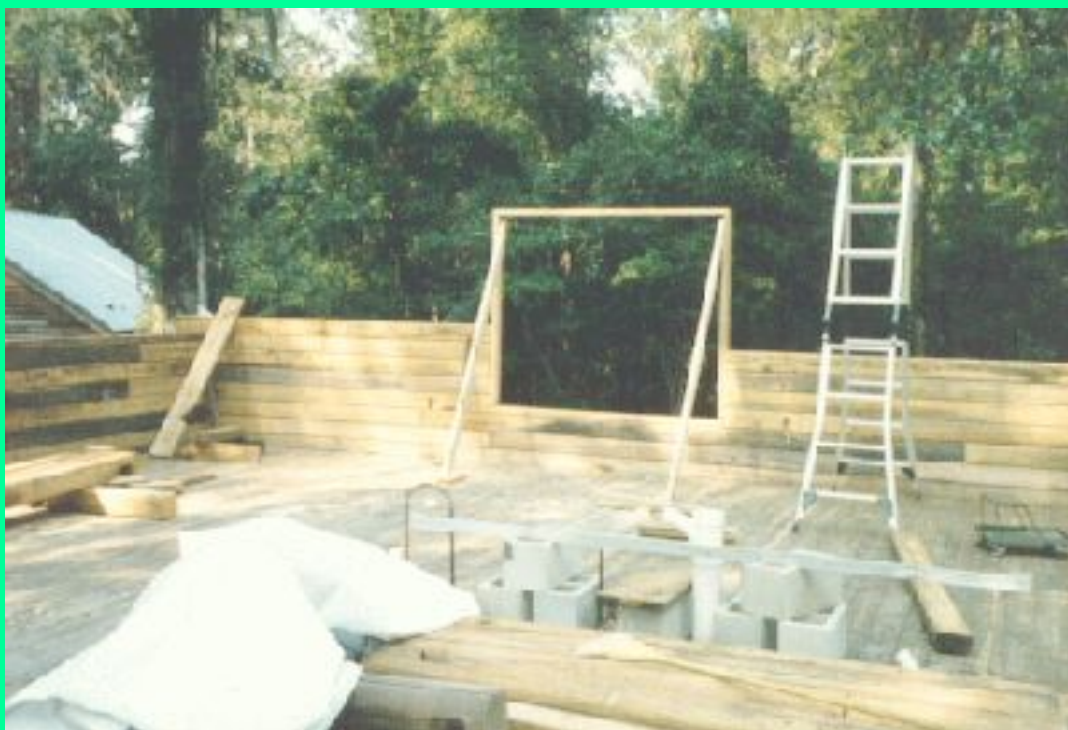
Rear window frame

The rear window frame for the
2nd floor north bedroom.
