Building a Log Cabin

Contained on this and following pages is a pictorial display of a 2-story log cabin house and adjacent 2-story garage recently built in the woods of North Florida, USA. The home was built by two people - Clyde and Rosemary - without the help of contractors or hired help. Clyde has worked full-time during most of the construction period, so only a few days of the week are available to work on the house. The home is built from logs bought at BK Cypress, Bronson, FL. This photo shows what the house looked like from the front in February, 1998.

Construction Photo Album

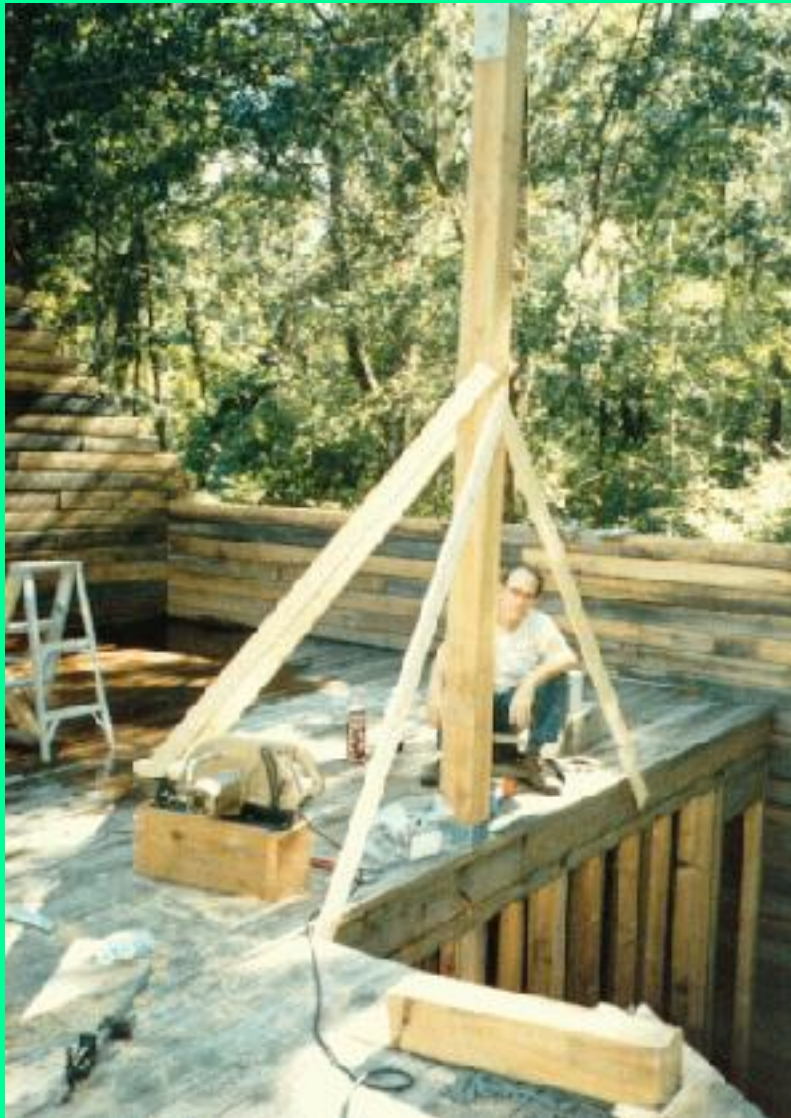
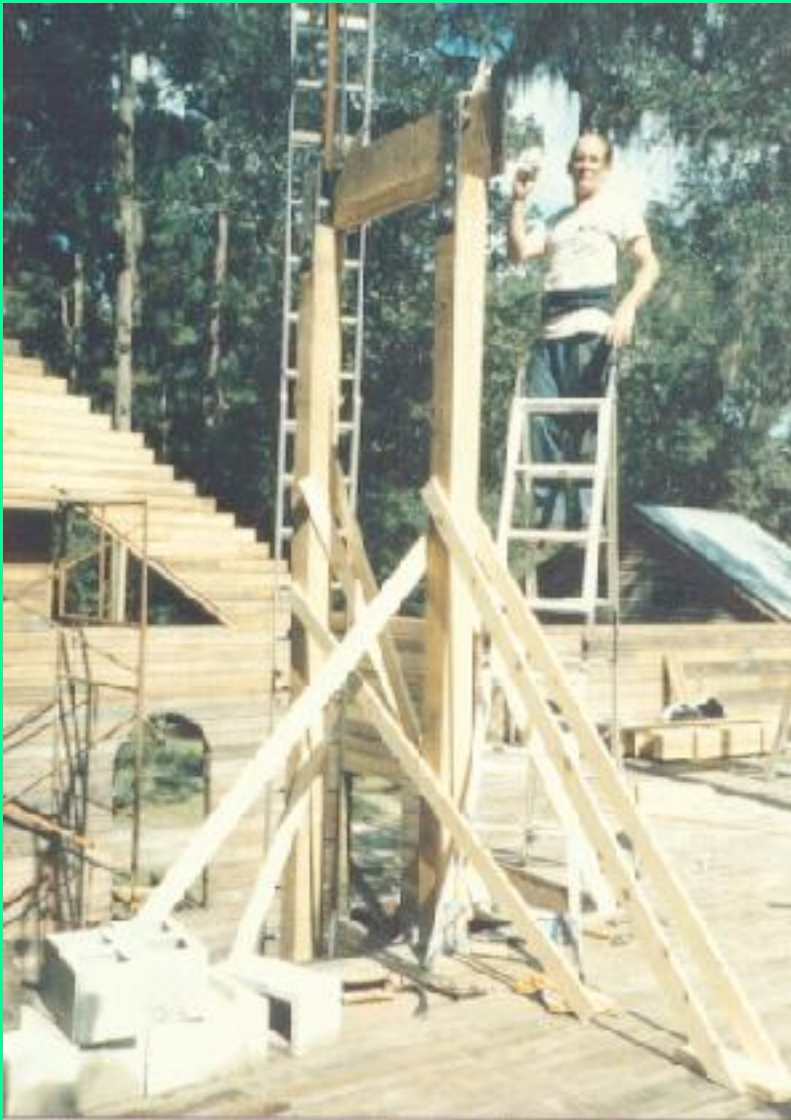
Here construction for the supports for the roof are put in place.

Center support
The ladder shown extends from the first floor level and provides a way for the builders to put in the support posts for the point where the 3 roof beams join as shown in the previous 2 photos.

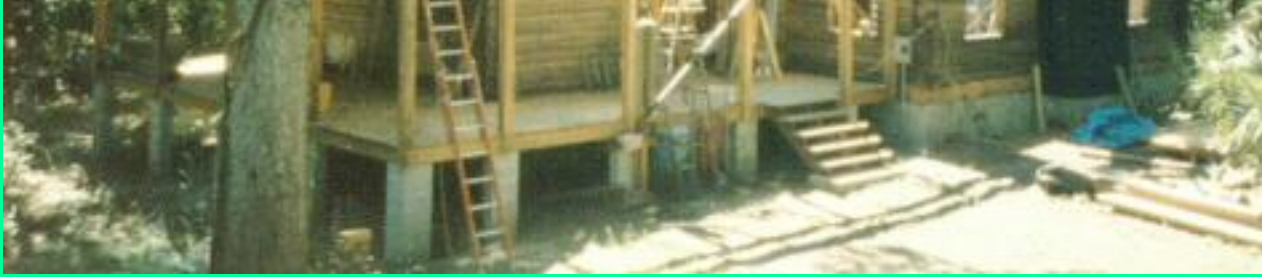
Other support frame

The support frame for the beams that will go on that side of the house can be seen. The frame is in the area where the 2nd floor bathroom is.

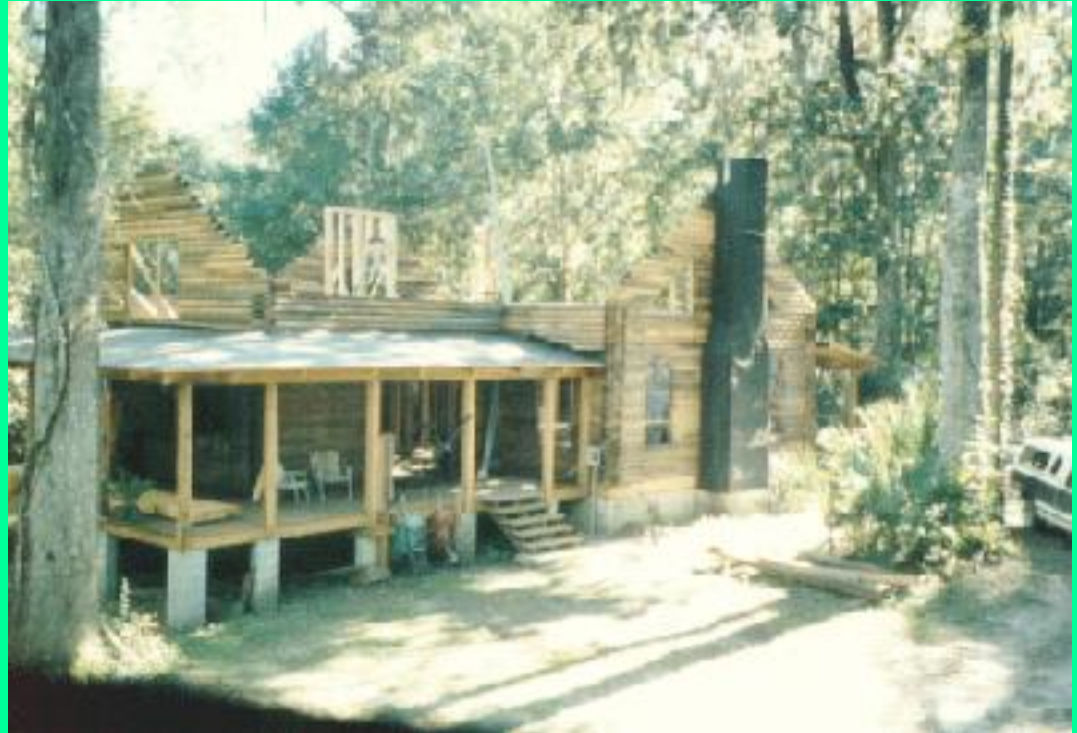
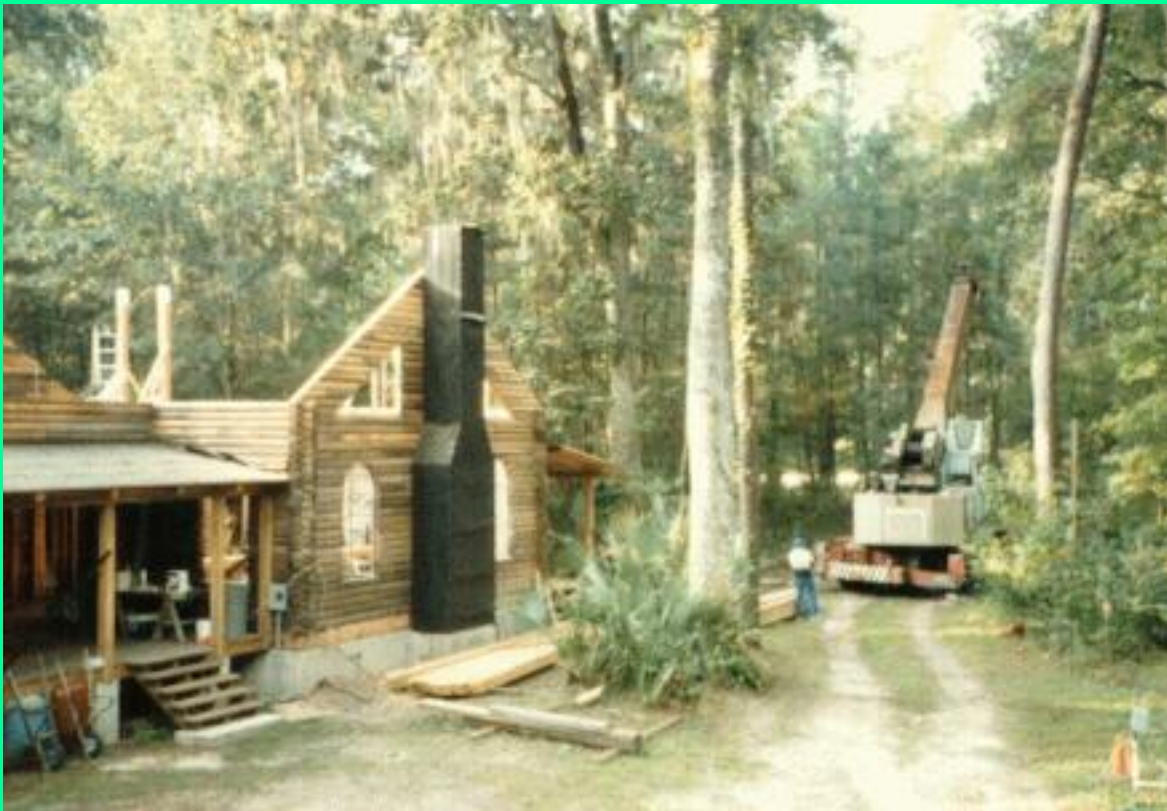
The Crane

One of the few times where outside help has been required. Remember the invention used to lift logs from before? That was tried to lift the roof beams. It didn't work so a crane had to be brought in as shown in this photo.

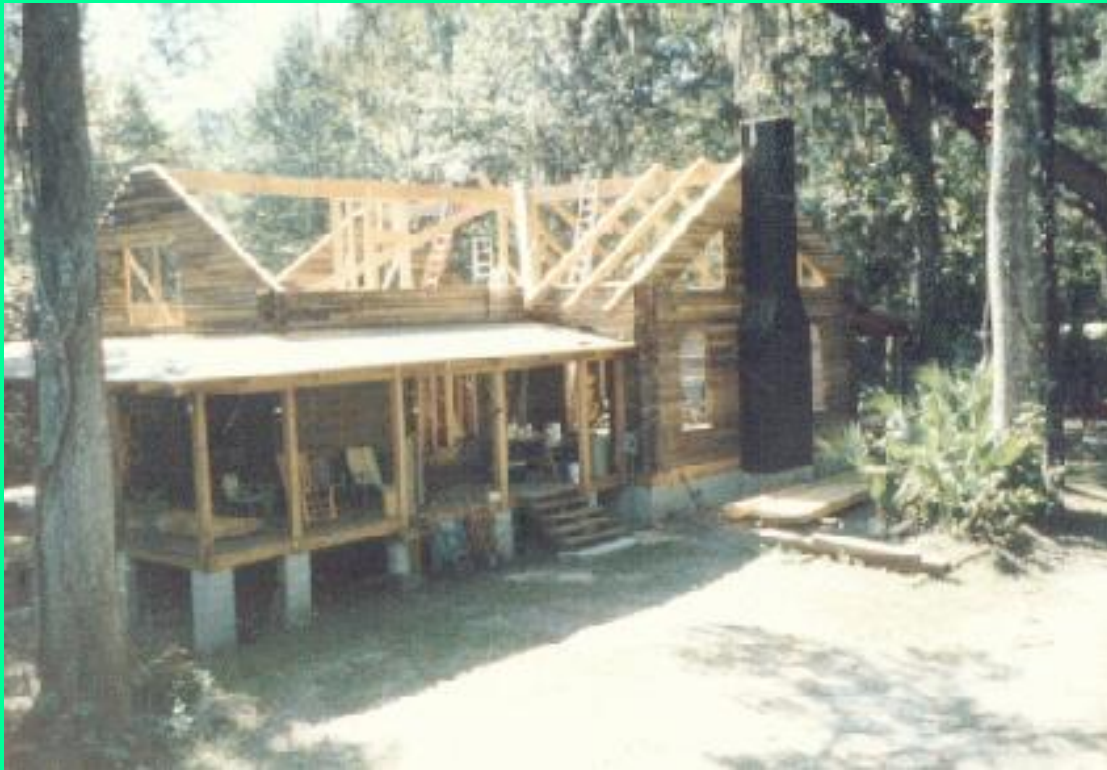
Beams go in

An early look at the roof support as the beams start to go up.

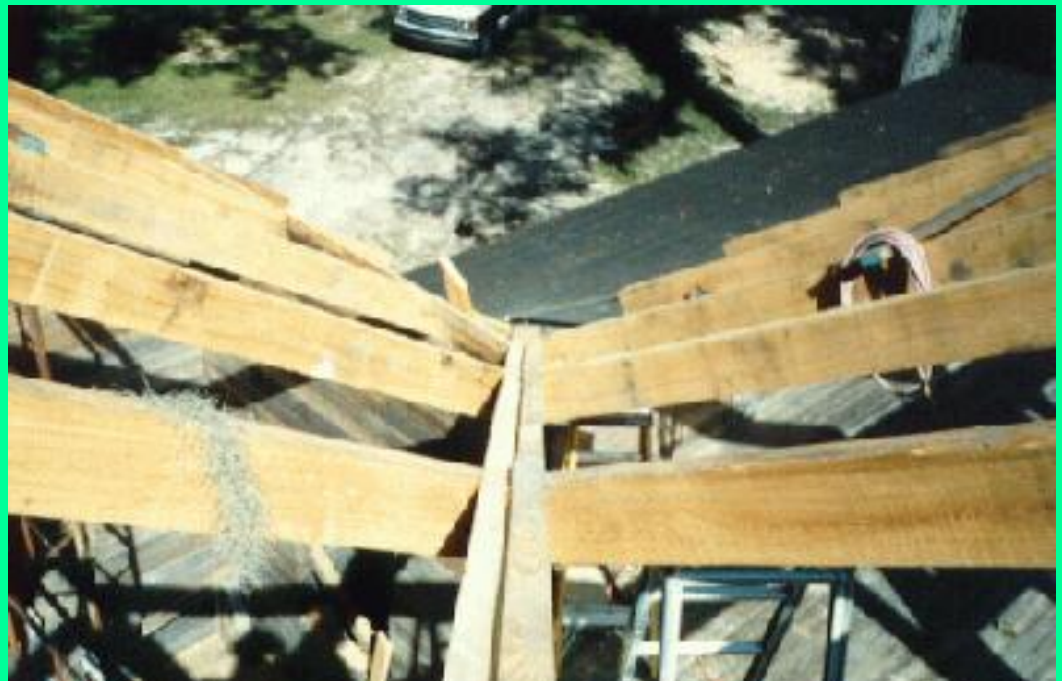
Support point

Point where the three main beams and two lesser beams meet. Note the large metal bolts.

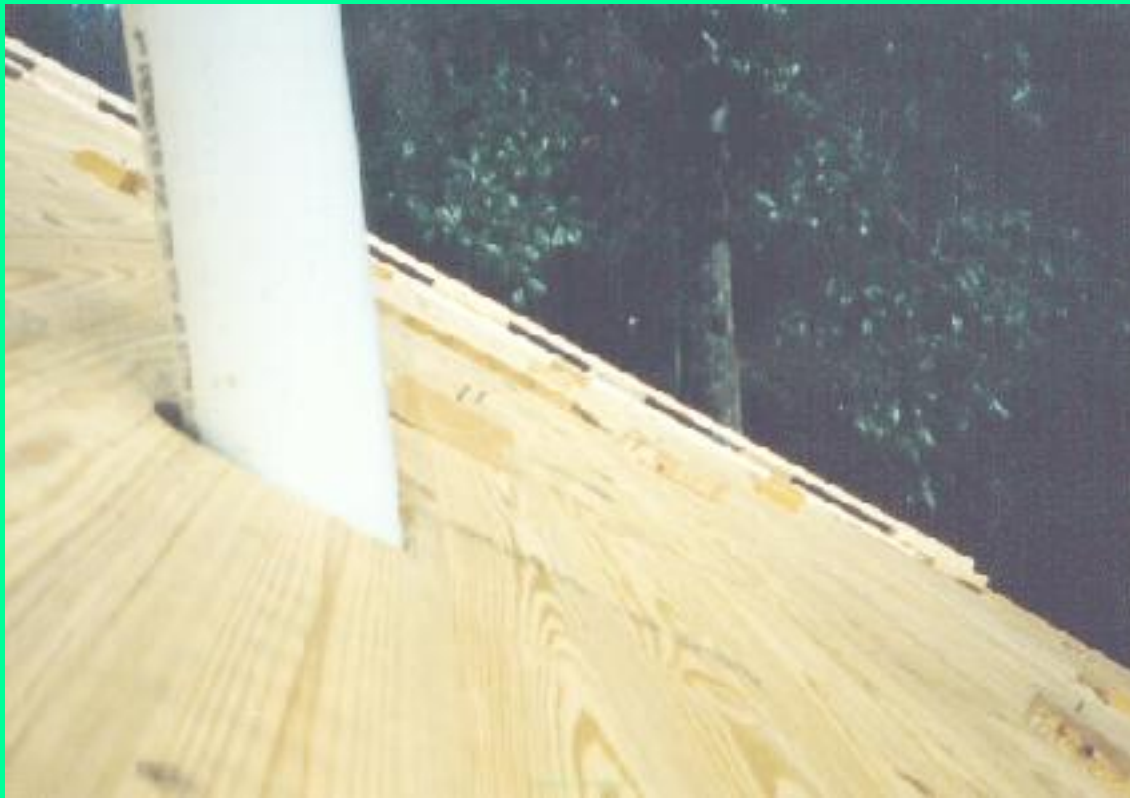
Sewer Vent

The sewer vent and one of the only pictures on the right (northeast) side of the roof.

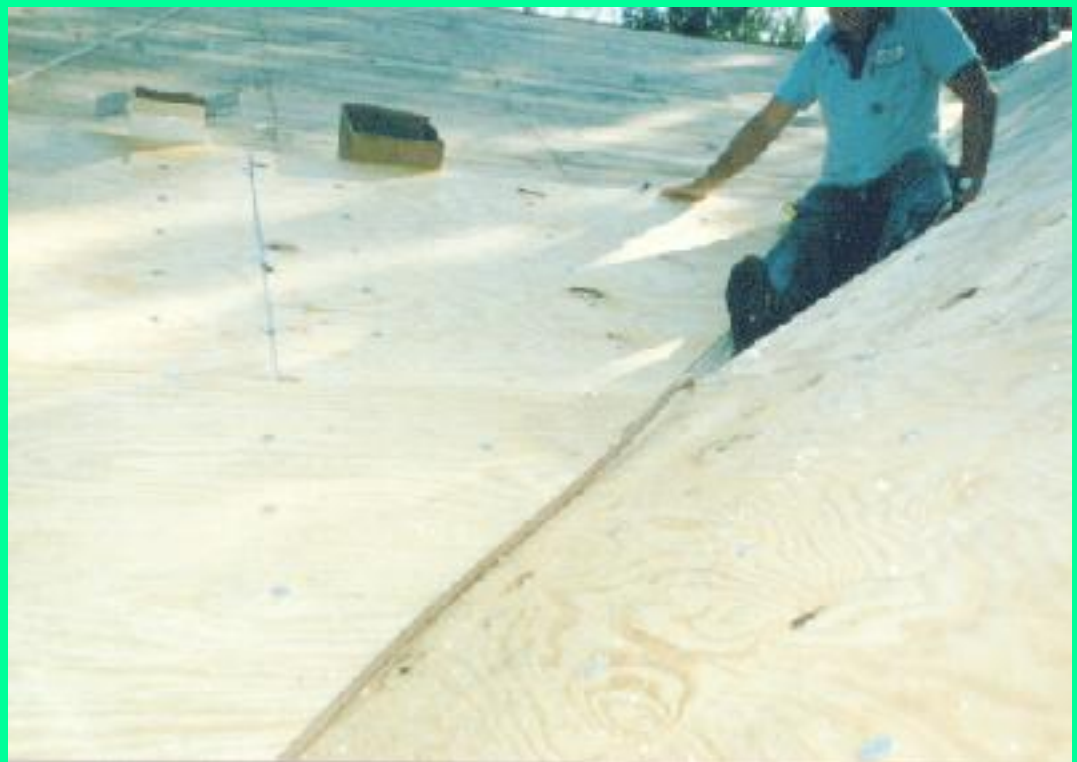
Tar paper has been laid on this section and the strips of wood to which the tin will be screwed in are coming into place. Here Clyde measures the last piece of the all important valley ridge.

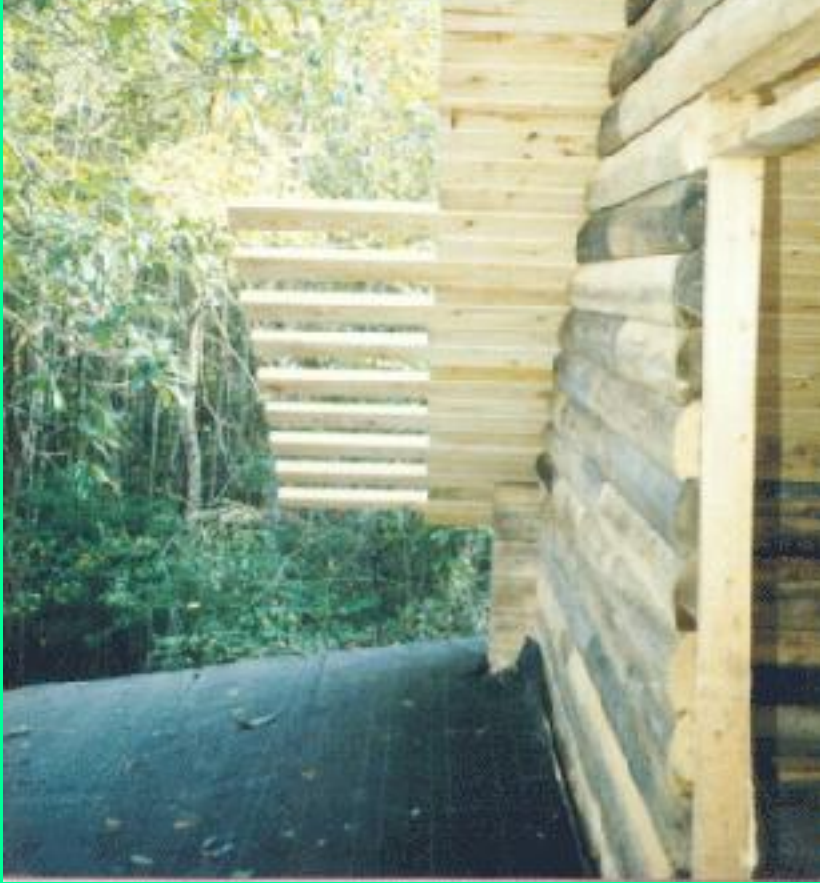
Roof side

A view of the roof from outside the north window looking toward the east side of the building (directions based on one looking at the house from the front door. Eg. The front door is south). The wood gets cut to an even spacing, a specific distance from the side of the house.

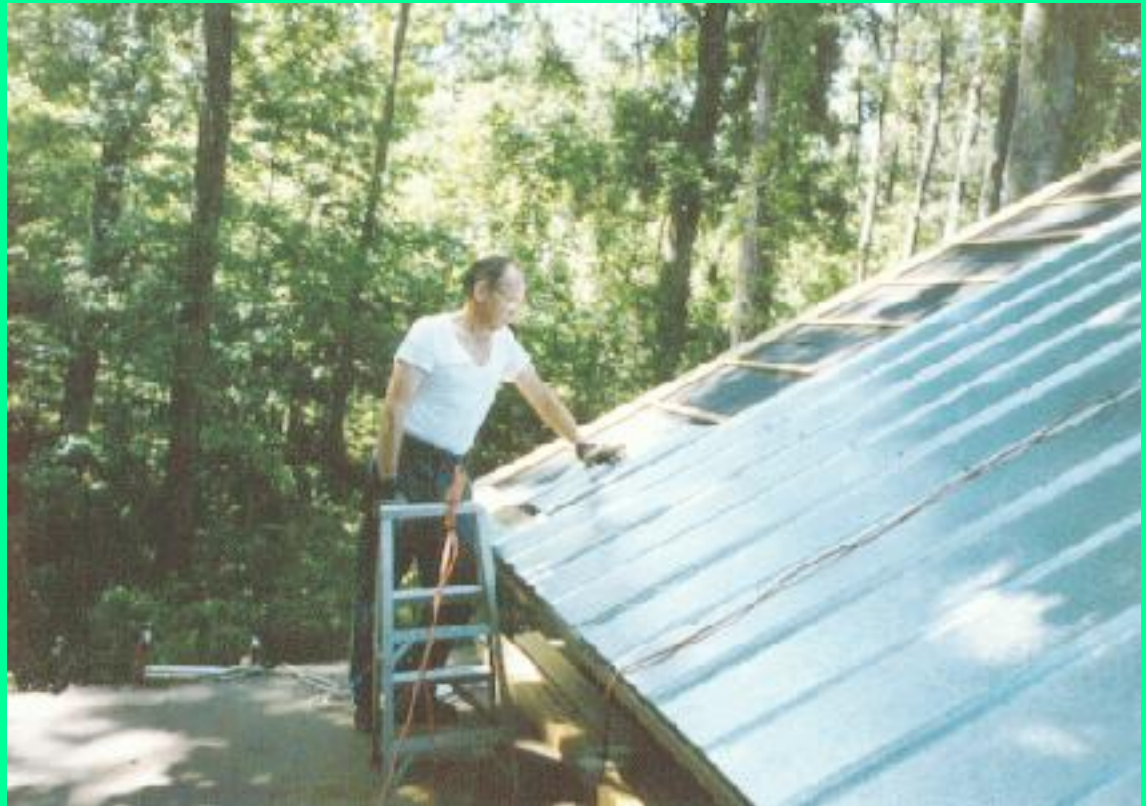
Tin goes up

Tin being put on. Notice Clyde is dressed for warm weather in this picture but at the beginning of the roof series, he is dressed for cold weather. Yes, it took that long to do all of this.

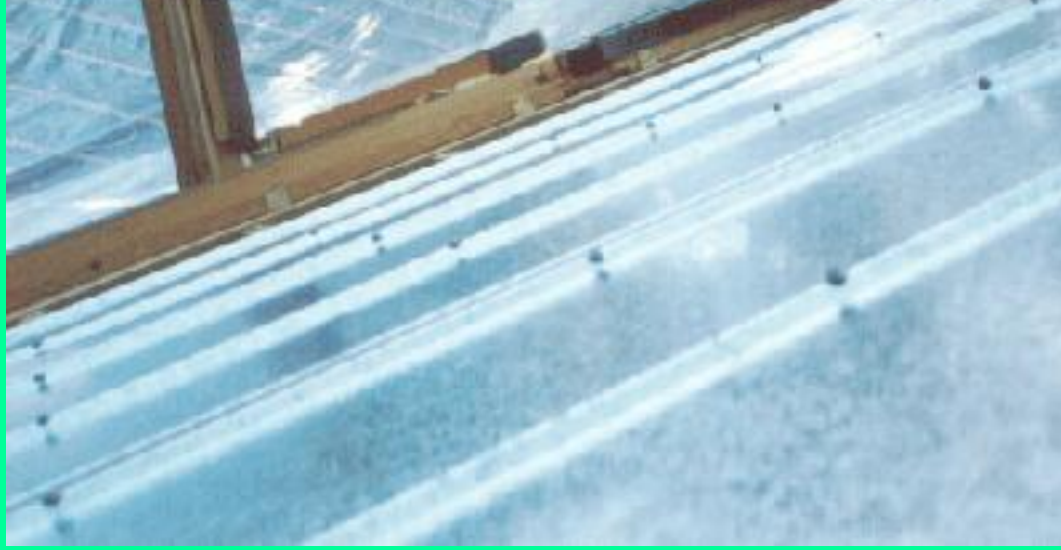
Skylights

A closeup view of the northeast corner of the house showing the bathroom skylight. This photo was taken from the skylight

located in the northern
bedroom.

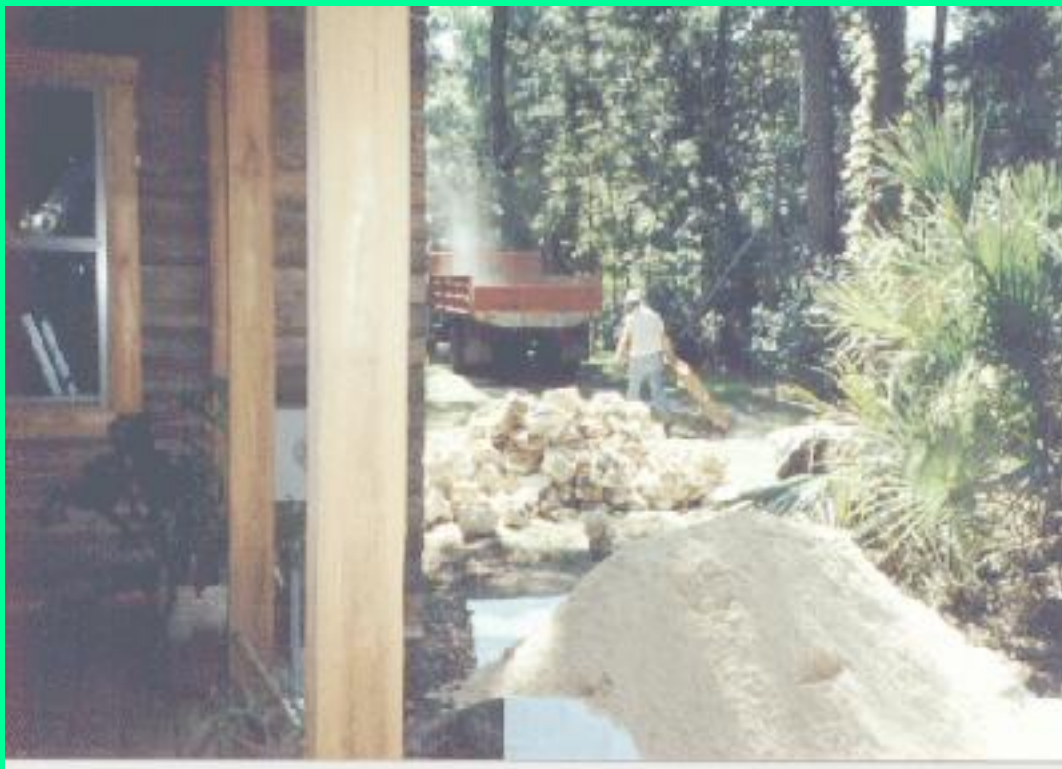
Stones and Sand

The 5 1/2 tons of Florida field stone and rock as well as 2 tons of special sand to be used in the mixing of the mortar is delivered. The stones had to be broken up with a sledge hammer in order to get small enough (and light enough) stones to go on the chimney.

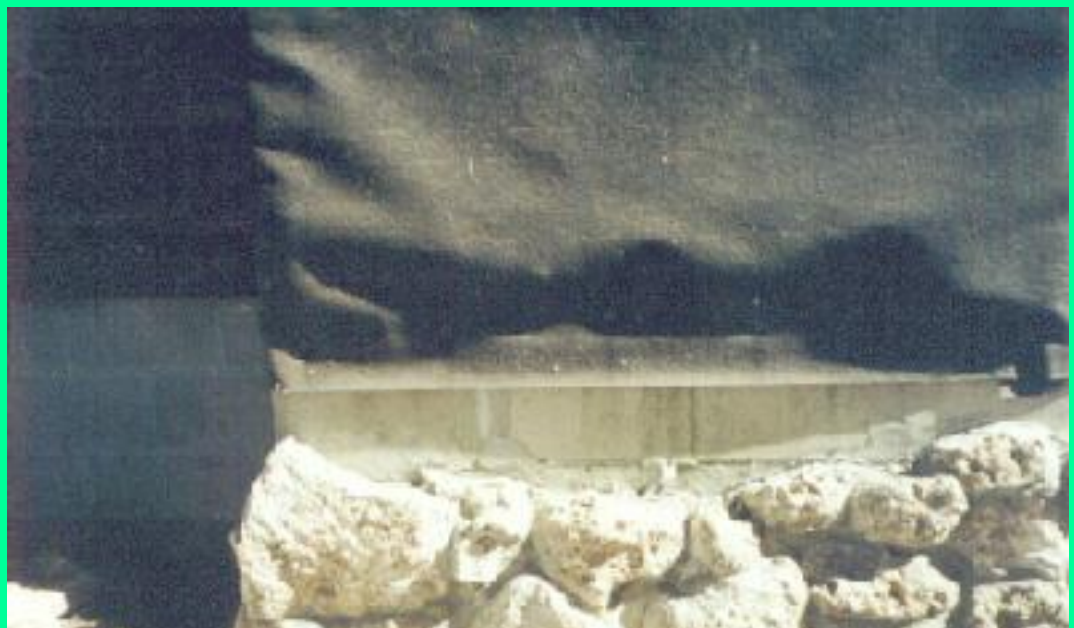
Chimney base

The base of the chimney on which all 5 tons or so of rock will sit.

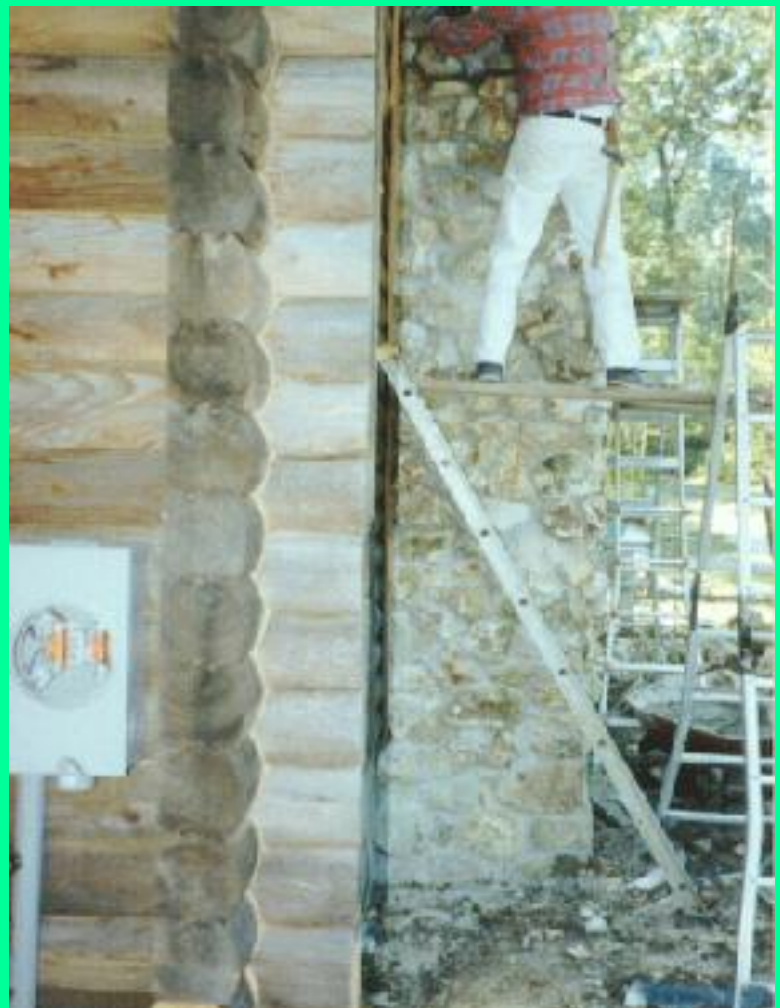
Stones and scaffolding

Side view of the chimney after a few days work. Approximately 2 rows of stone, all the way around the chimney could be done for each day of work. The lowest outside temperature had to be over 50 (F) so the winter months sometimes prevented us from working. (Fortunately, in this part of Florida, that was only a month or so of not being able to work).

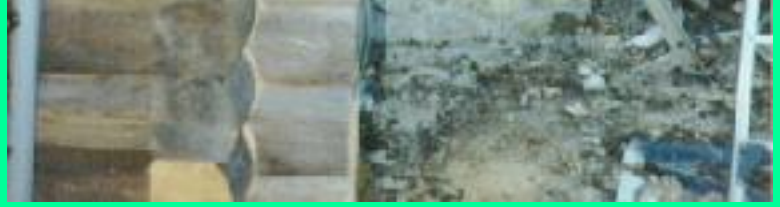
Bucket by bucket

Stones are lifted up bucket by bucket. The mortar is also lifted bucket by bucket. Note make-shift platforms and plastic to prevent mortar from falling on existing stone.

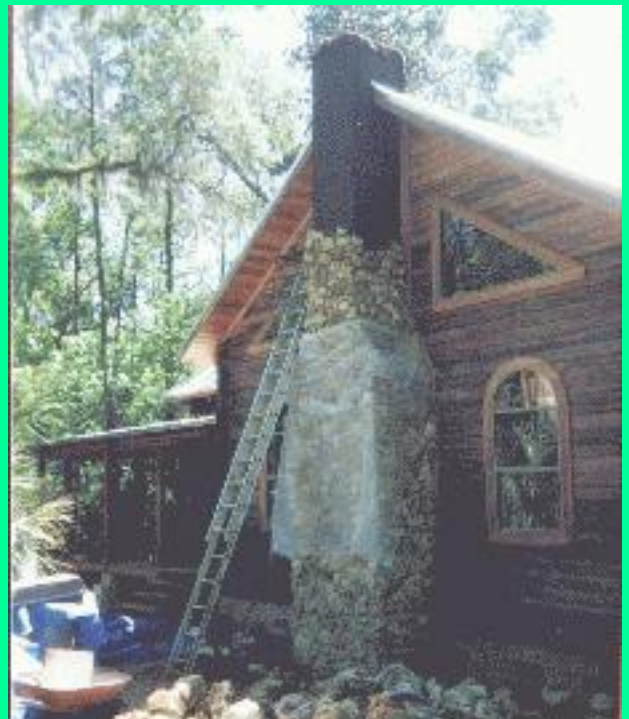
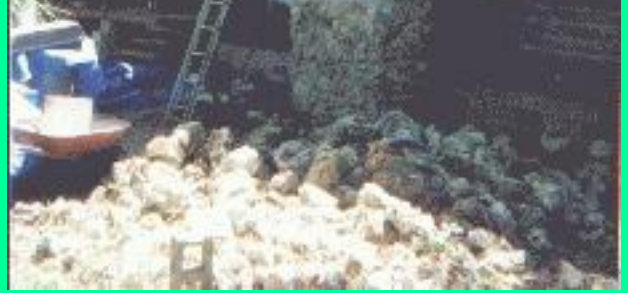
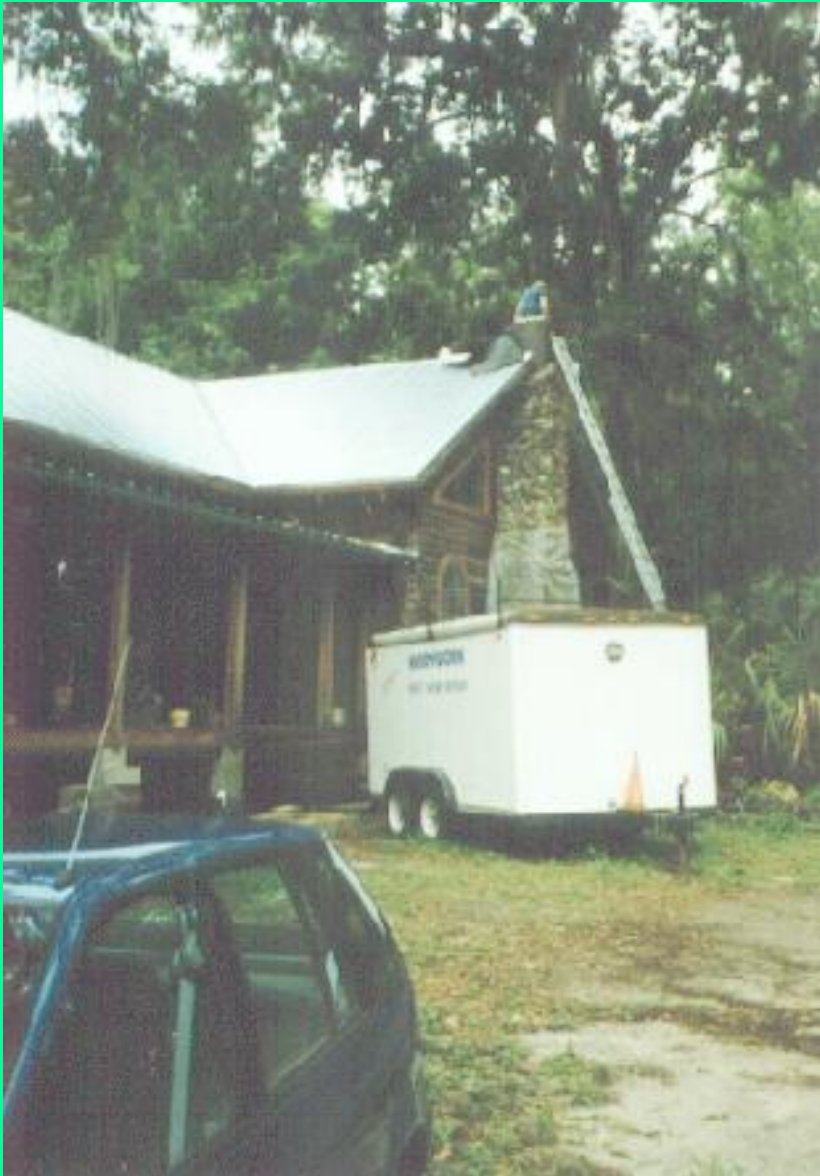
Almost done

Look carefully at the top of the chimney. Clyde is **in** it lifting stone and mortar as he works toward finishing the stone. The chimney has since been finished. The interior flue pipe and top to the chimney is on and inspected.

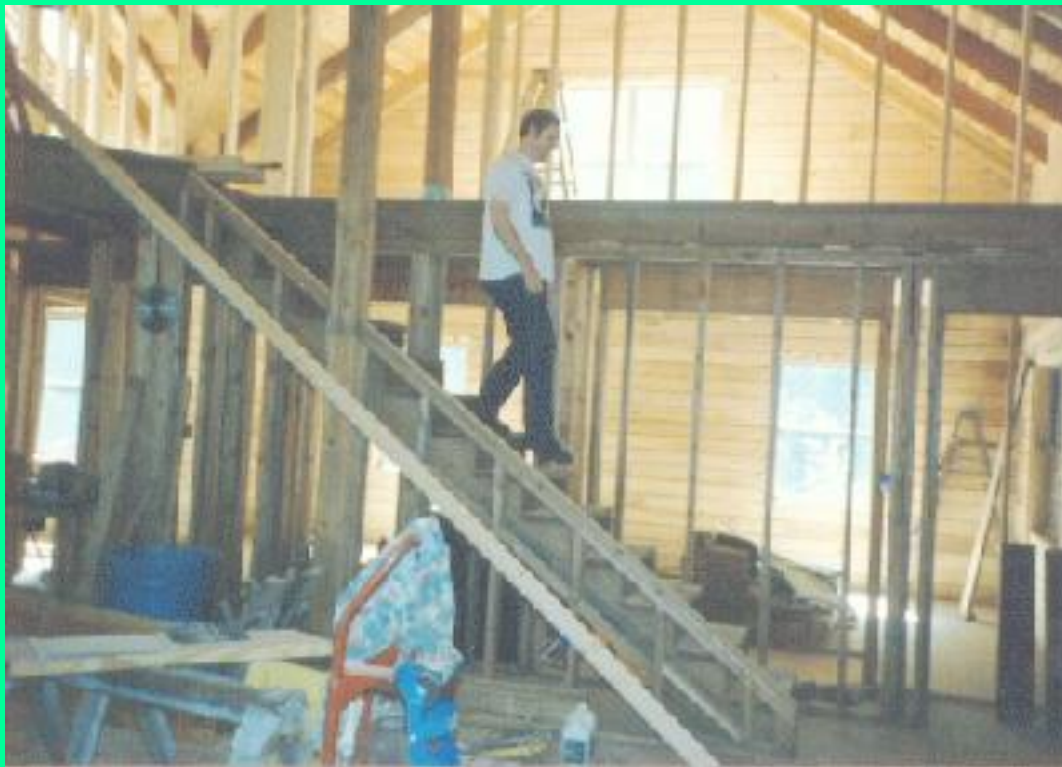
Stair & wall frames

Clyde's son, James (yours truly) comes down the stairs. In the background one can see the framing of parts of the 1st and 2nd floor walls.

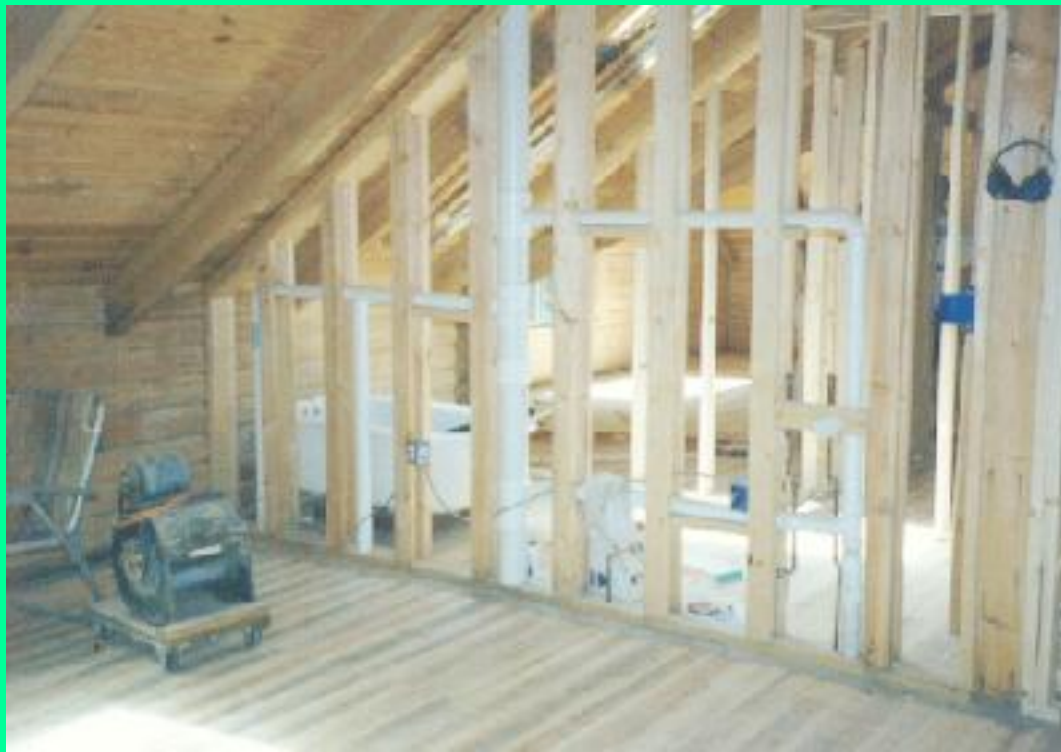
2nd floor plumbing

A look from the back bedroom toward the bathroom. Notice the plumbing in the wall and the claw-foot bathtub being stored in the bathroom.

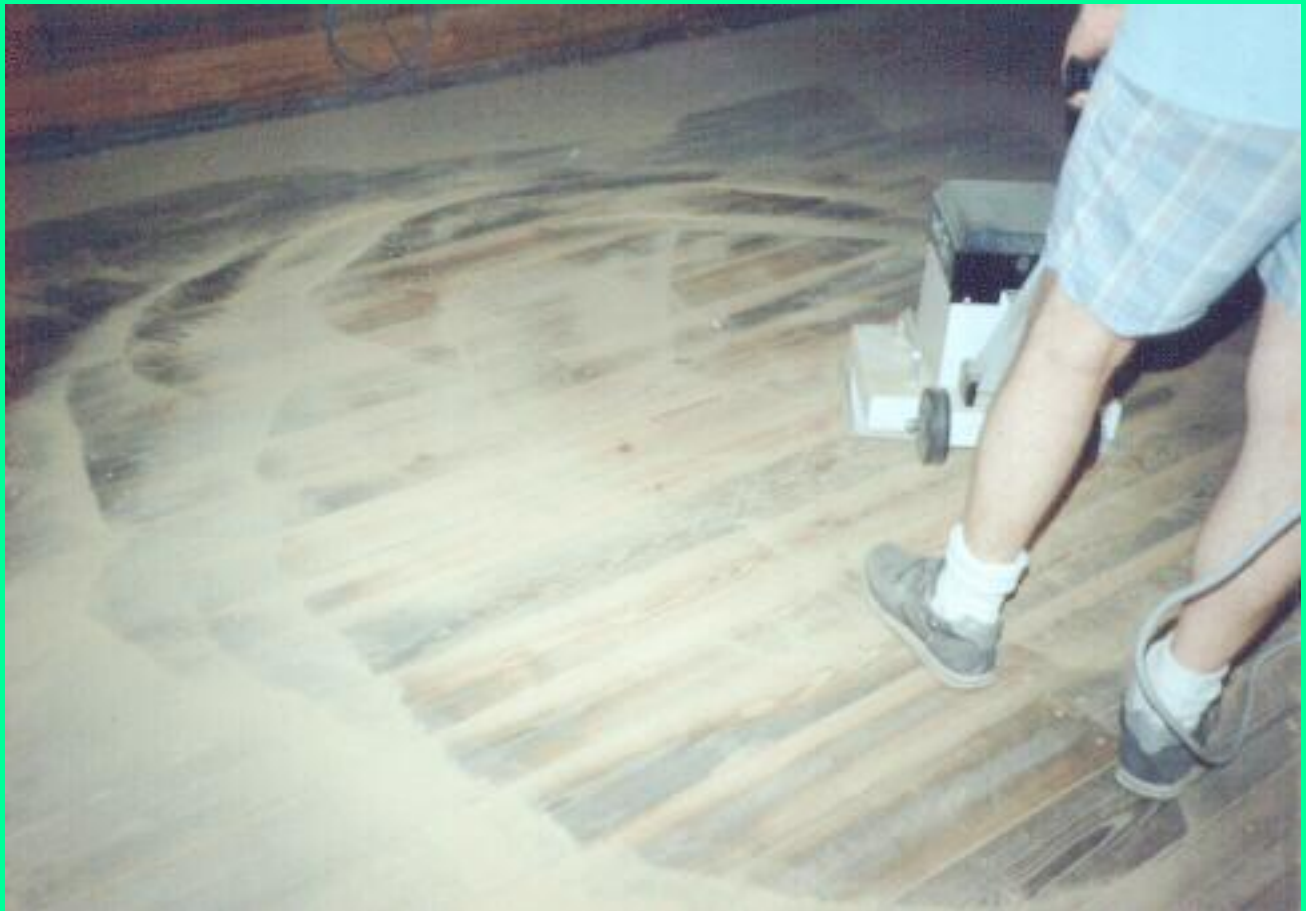
Floor

Sanding the 2nd floor floor. This was necessary due to the floor being exposed to the elements for so long.

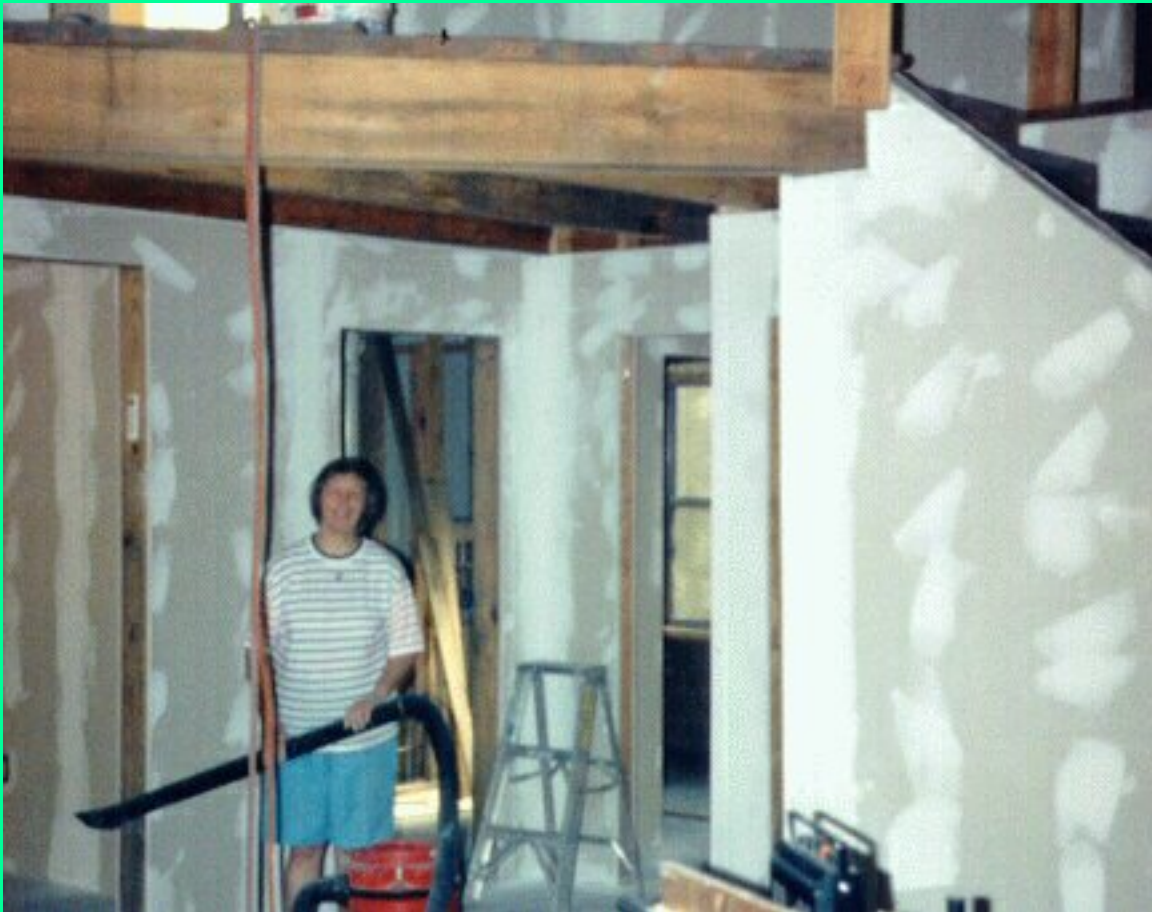
1st floor sheet rock

As Rosemary cleans up, you can see the sheet rock on the first floor. Looking at bathroom and master bedroom entrance.

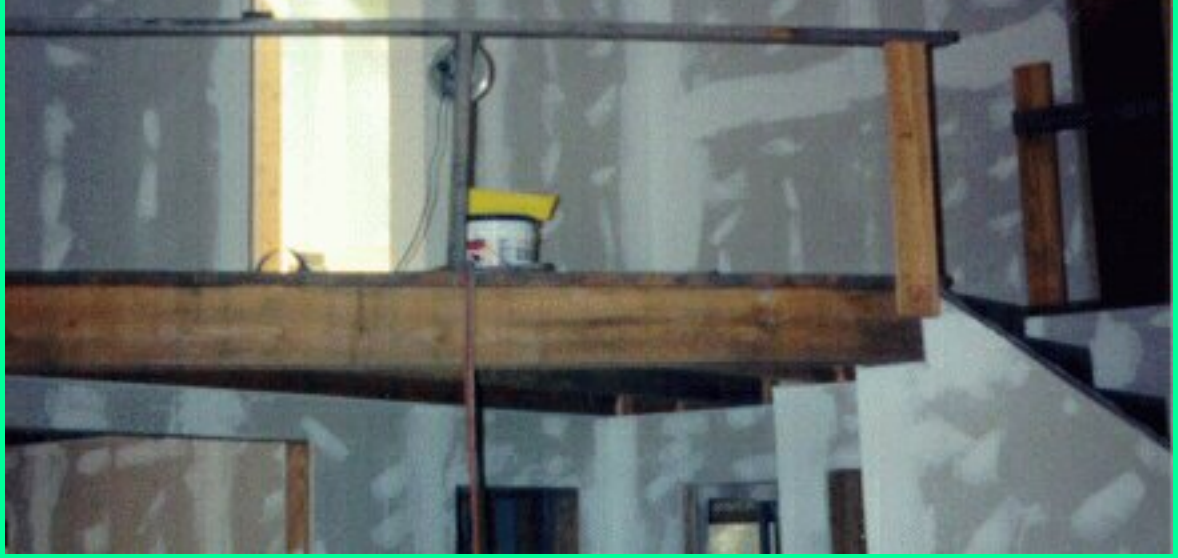
2nd floor bathroom
Rosemary is painting the
2nd floor green-board.

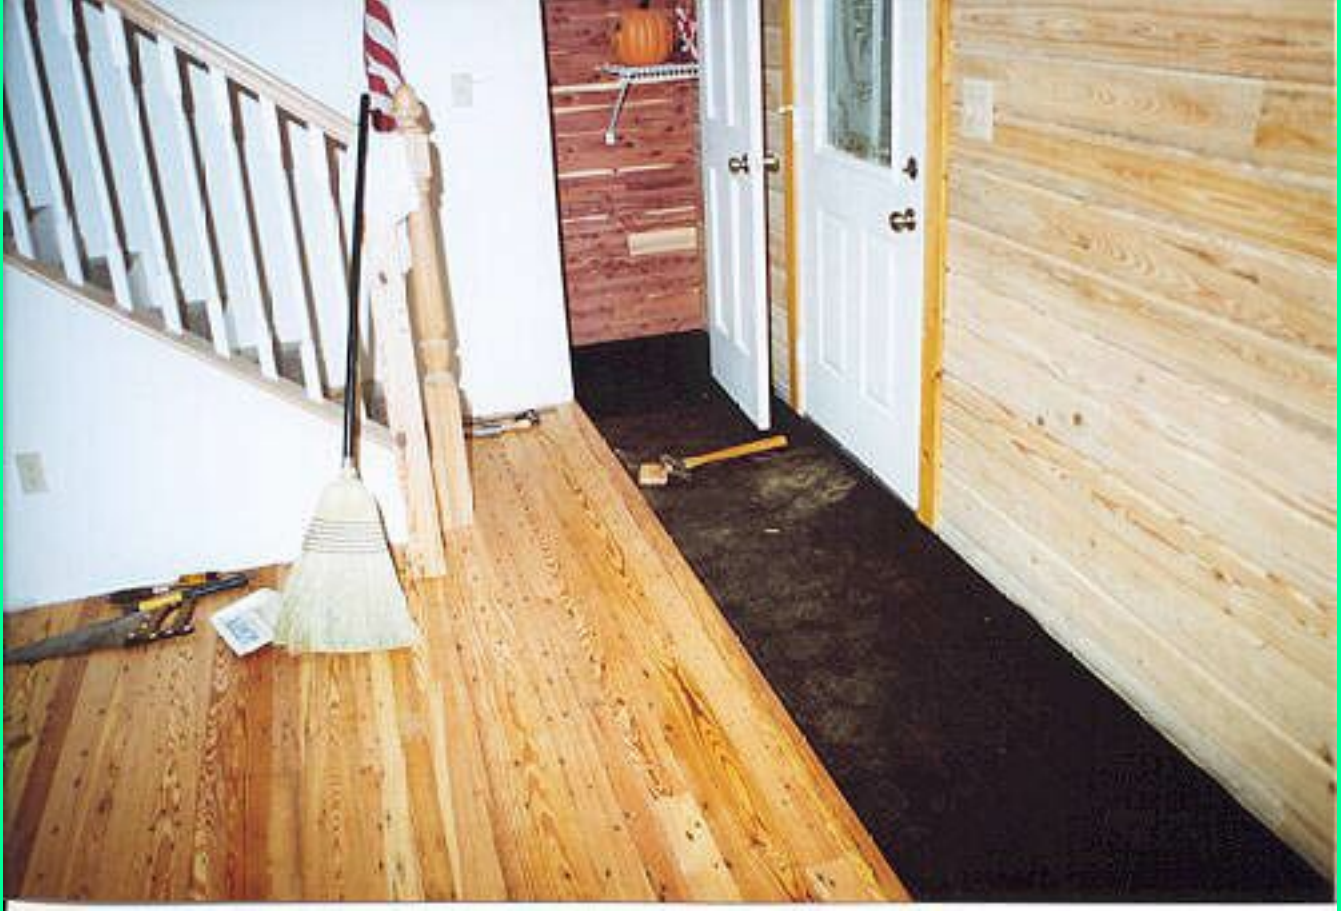
Floor installation

By the stairway and doors the wood had to be custom cut.

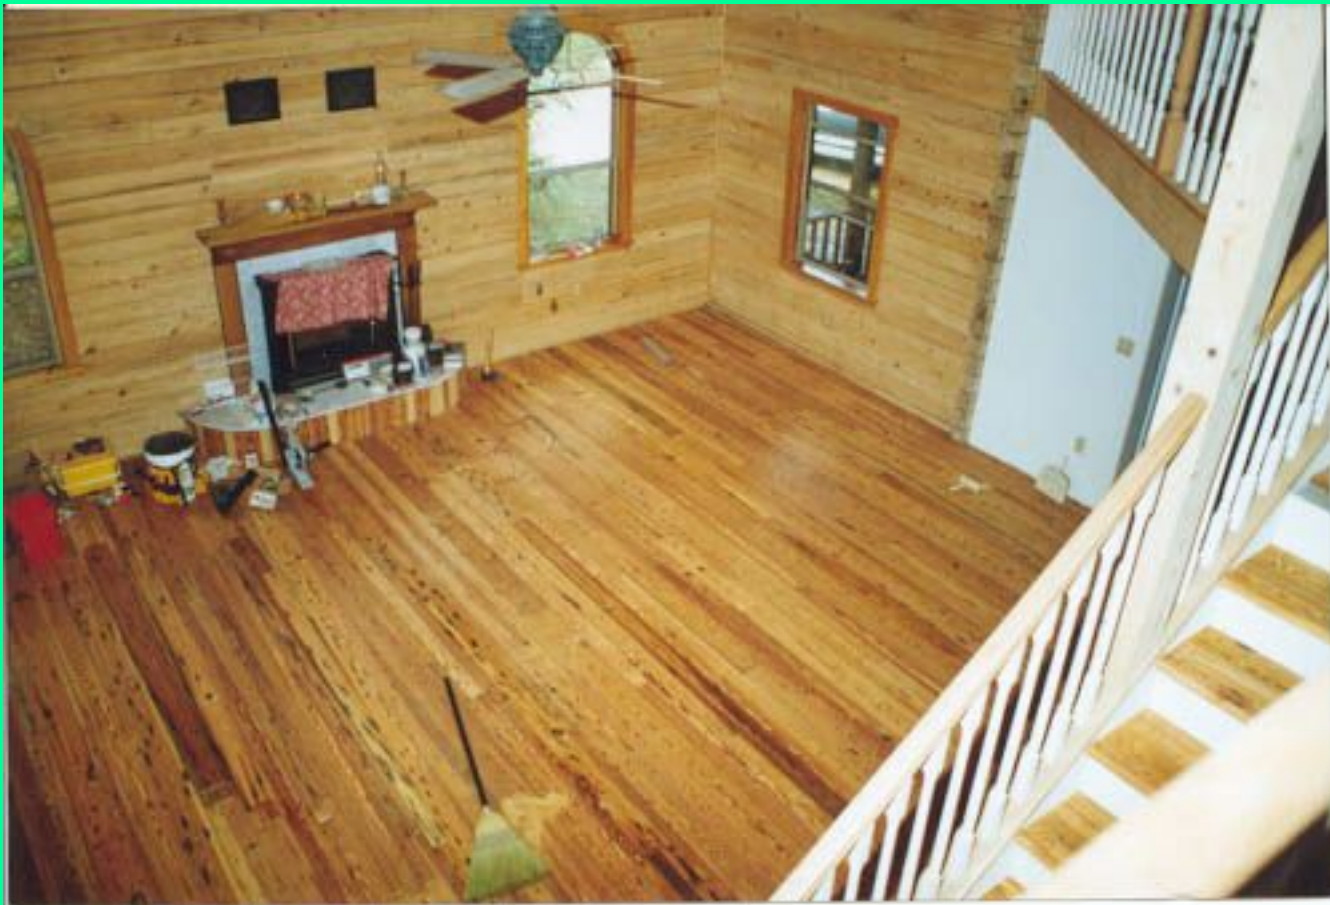
Floor installation

An overview of the nearly completed flooring before the polyurethane covering was applied.
